July 31, 2019

**RE: Limited Hazardous Materials Survey Report  
Chula Vista High School  
Administration Building (Elevator Addition Project)  
820 Fourth Avenue  
Chula Vista, California 91911  
Vista Project No. 190537002**

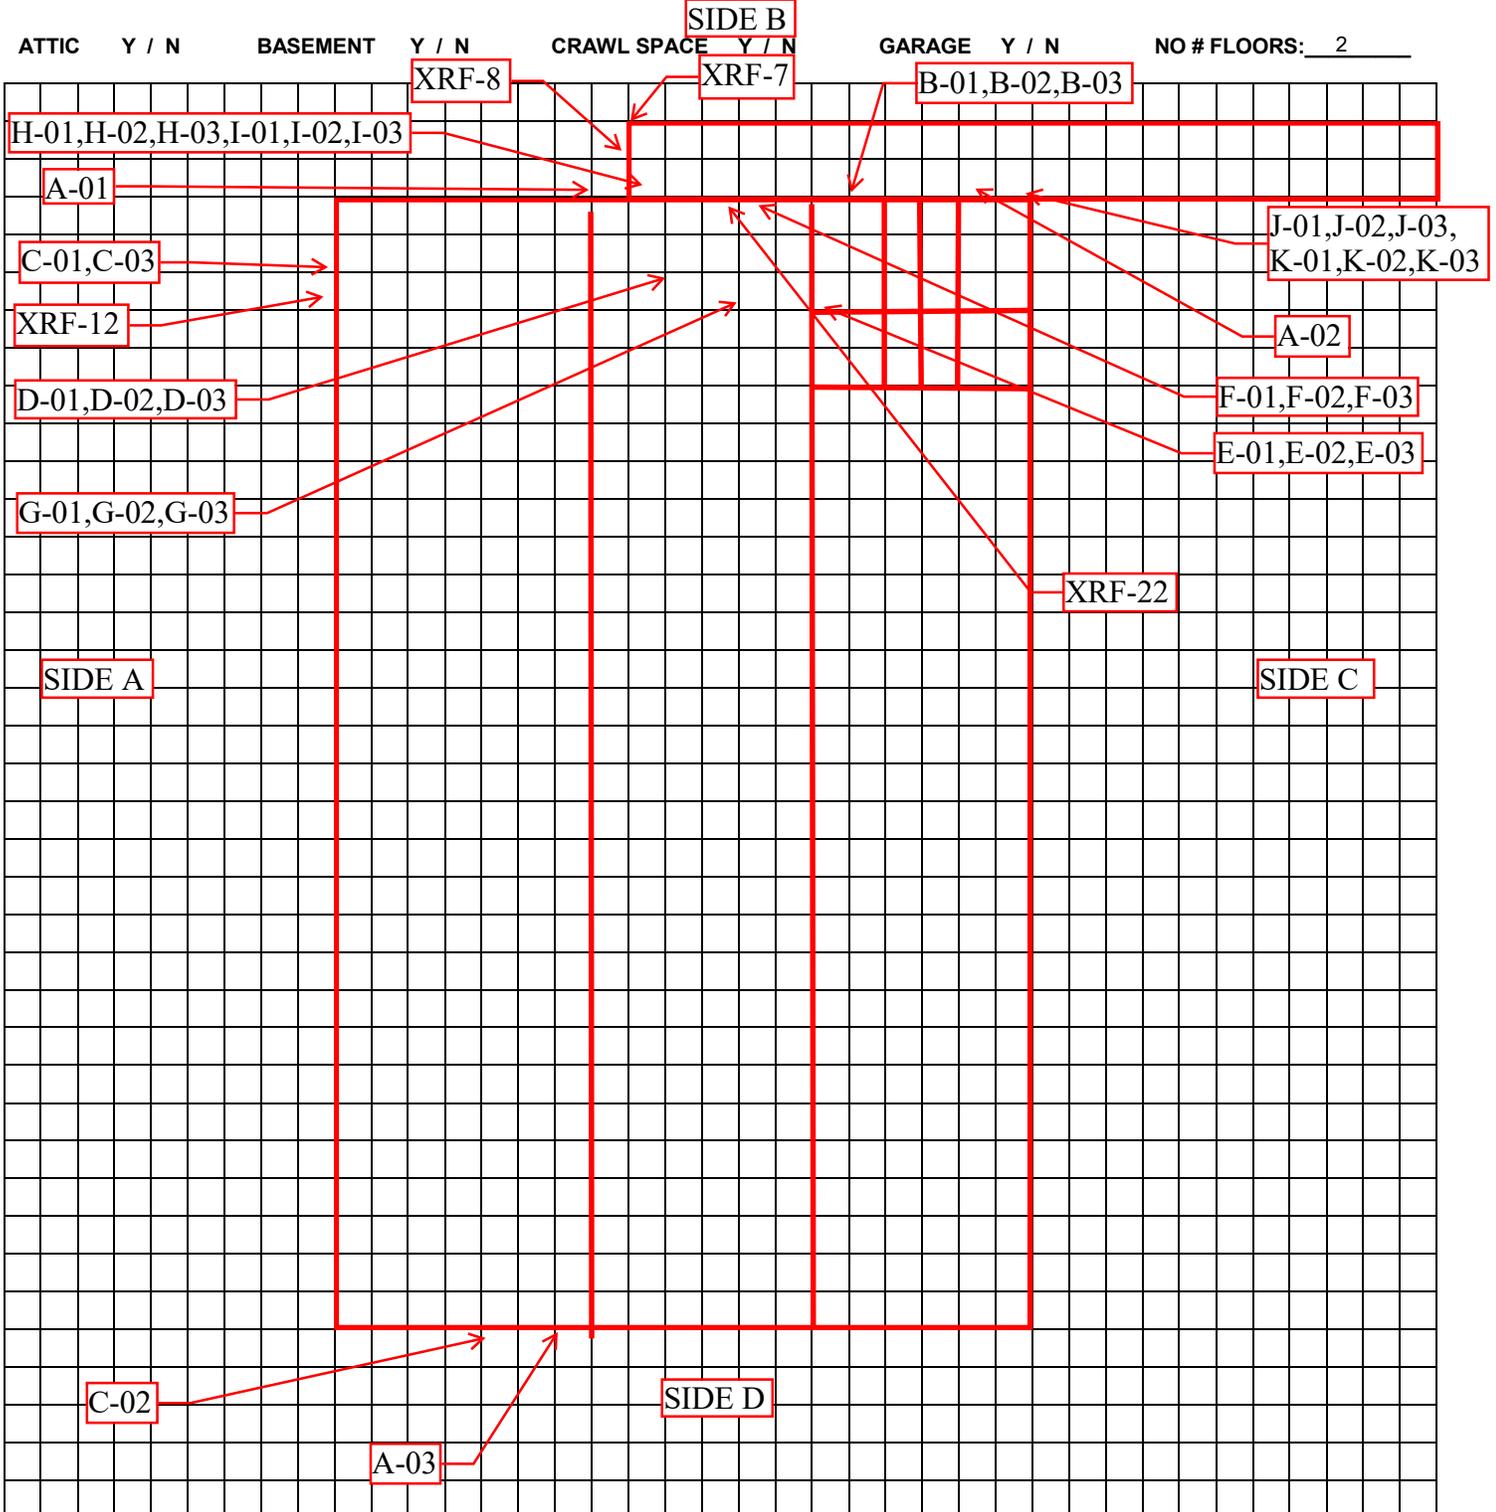
Building: 100

Vista Inspector: Michael Tangonan
