### CASA CASILLAS – ARTIST SPACE ASBESTOS & LEAD-BASED PAINT SURVEY REPORT

## **Asbestos & Lead-Based Paint Survey**

**50 North 4st Chula Vista CA. 91910**

**November 10, 2021**

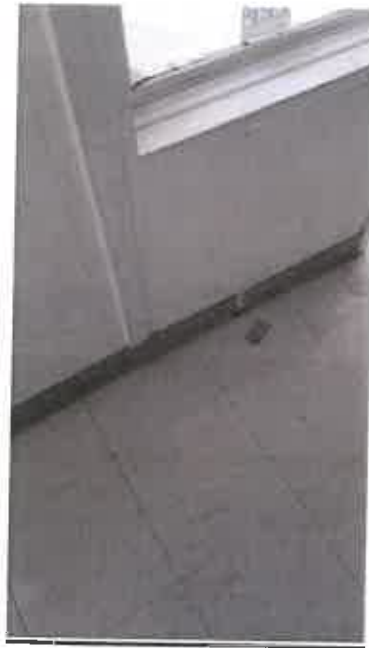
PB- Sample 09 White Lead Containing Paint on Interior Window Frames

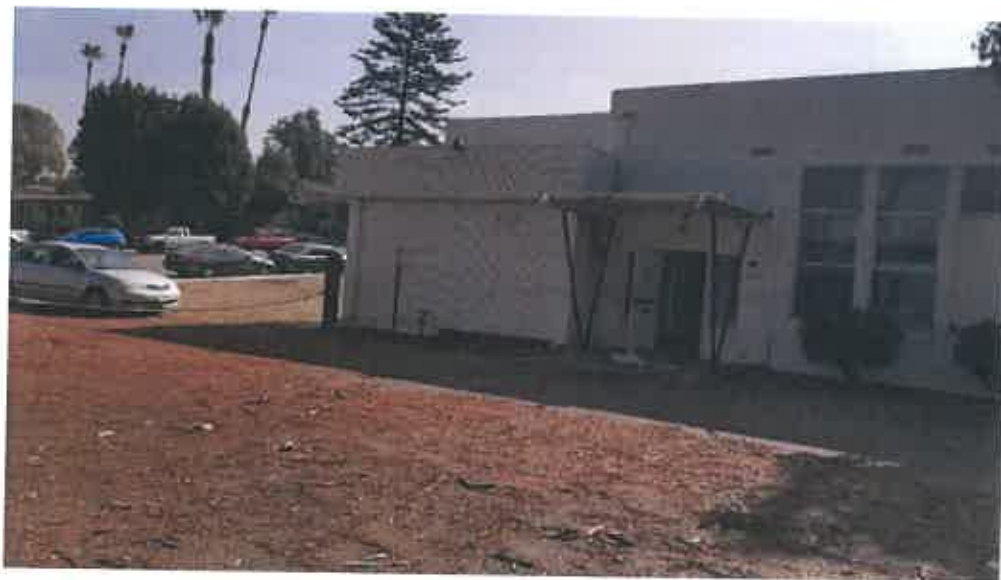
Sample	Sample Location	Sample Description	mg/kg lead	Condition	Approx. Amount
10	Exterior Window Frames	White Paint	10000 mg/kg	Intact	350sf

PB- Sample 10 White Lead Base Paint on Exterior Window Frames  
PB Sample 11 White Lead Containing Paint on Exterior Stucco Walls

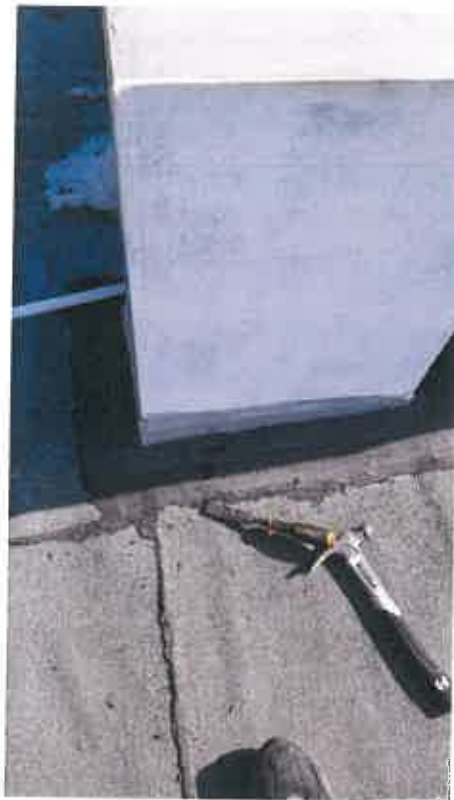
**PB Sample 14 White Lead Containing Paint on Exterior Stucco Walls on the Roof**

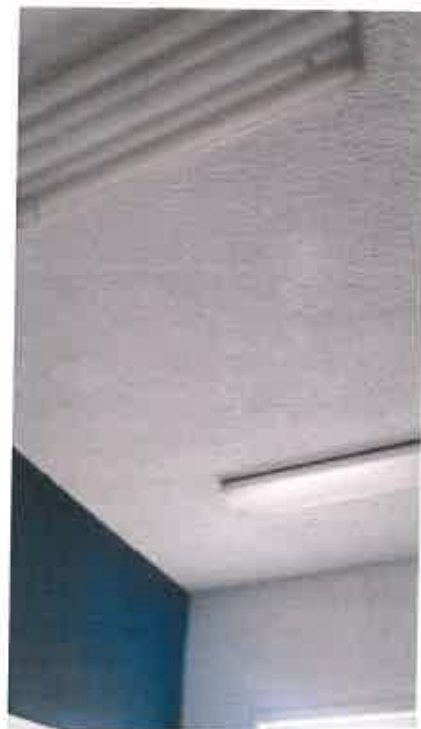
**AB Samples 18-20 White Sprayed on Acoustical Ceiling**

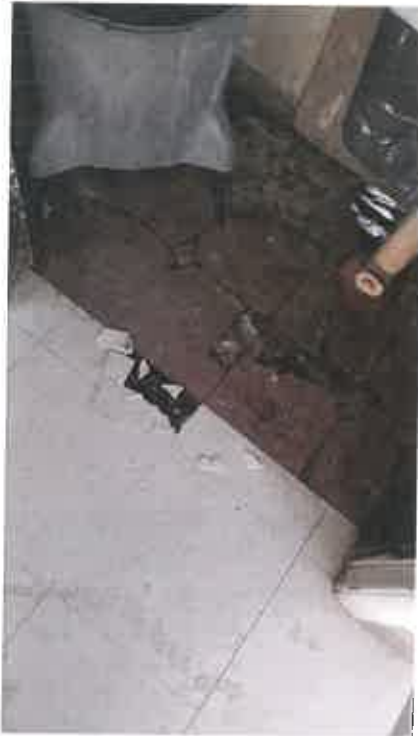
**AB Samples 41-46 Red 9x9 Floor Tiles, Black Mastic in Janitor Room**

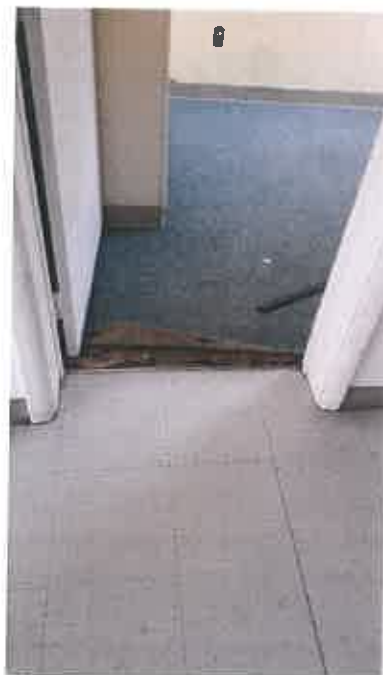
**Ab Samples 50,51 Black Mastic under White 12x12 Floor Tile**

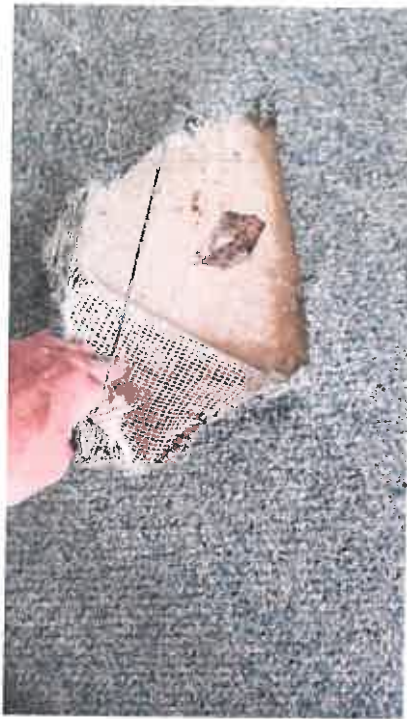
**AB Samples 53,54,58 12x12 Floor Tiles, Black Mastic under Blue Carpet**

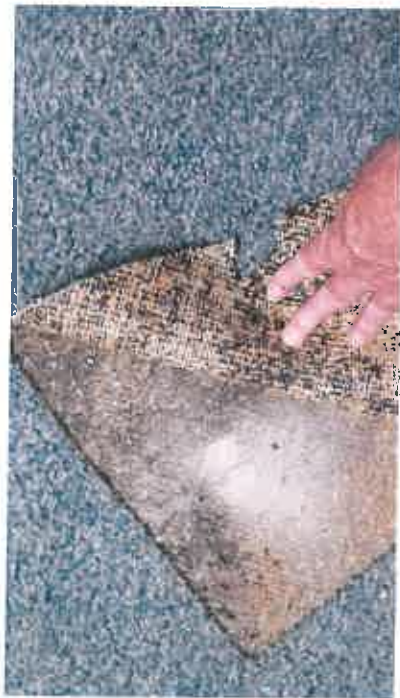
**AB Samples 59,60,61 12x12 Floor Tiles, Black Mastic under Gray Carpet**

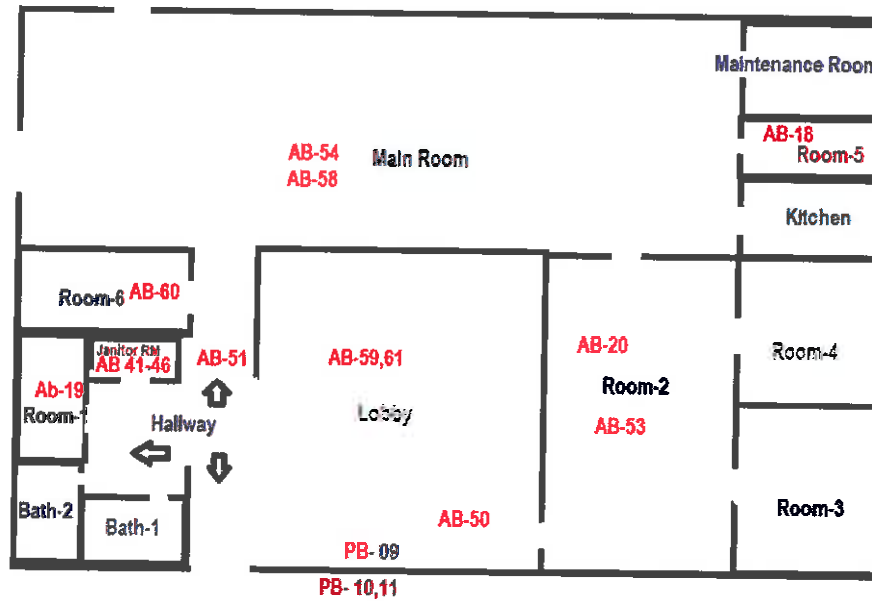
Positive Location Map

PB - 14 on Roof

AB 38,39 on Roof
