APPENDIX A - Geotechnical Report

July 5, 2018

Subject: **COASTAL BLUFF AND LANDSLIDE STABILITY
BEACON'S BEACH ACCESS RECONSTRUCTION PROJECT
ENCINITAS, CALIFORNIA
AECOM Project No. 60539890**

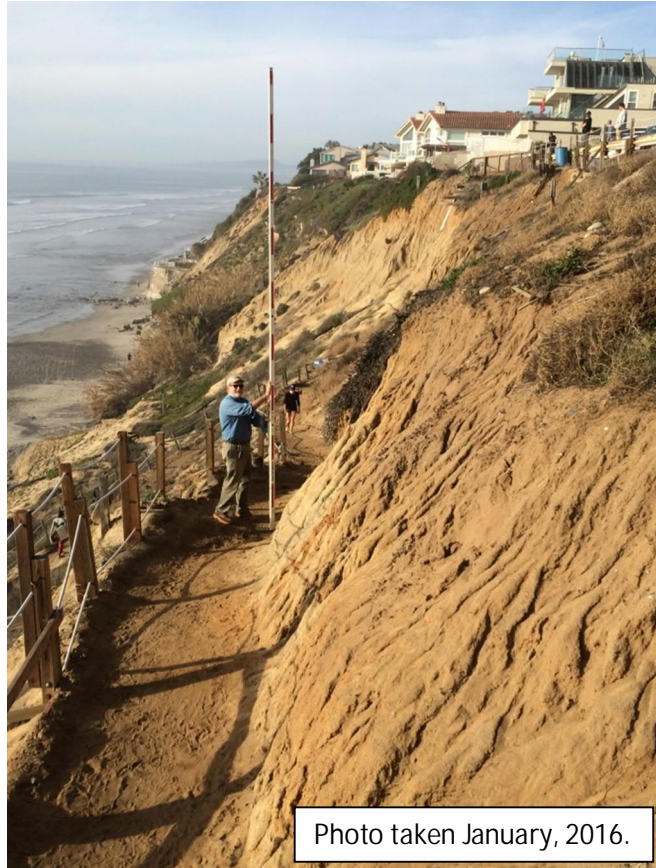
Some amount of elevation change is due to regrading to maintain the trail. According to the City, minor sloughing of the slope just below the top switchback has temporarily closed the trail and required the path to be regraded (notched) several feet landward. The uppermost portion of the trail (just below the highest switch back) has been built up several feet with fill soil to create a relatively uniform grade (indicated by blue contours, Figure 2). In effect, the upper trail is maintained with a thin fill slope placed along the edge of the naturally eroded, partially man-made cut made along the over steepened landslide head scarp (see photo at right).

It will be difficult to keep the trail open at the top section with continuing natural erosion and slope sloughing (URS letter to CCC dated February 16, 2016). Sections of the trail are also becoming increasingly unstable due to the increased accumulation of loose, sloughed material upslope of the trail. Tension cracks have been recently observed within these materials after rain (AECOM, 2017).

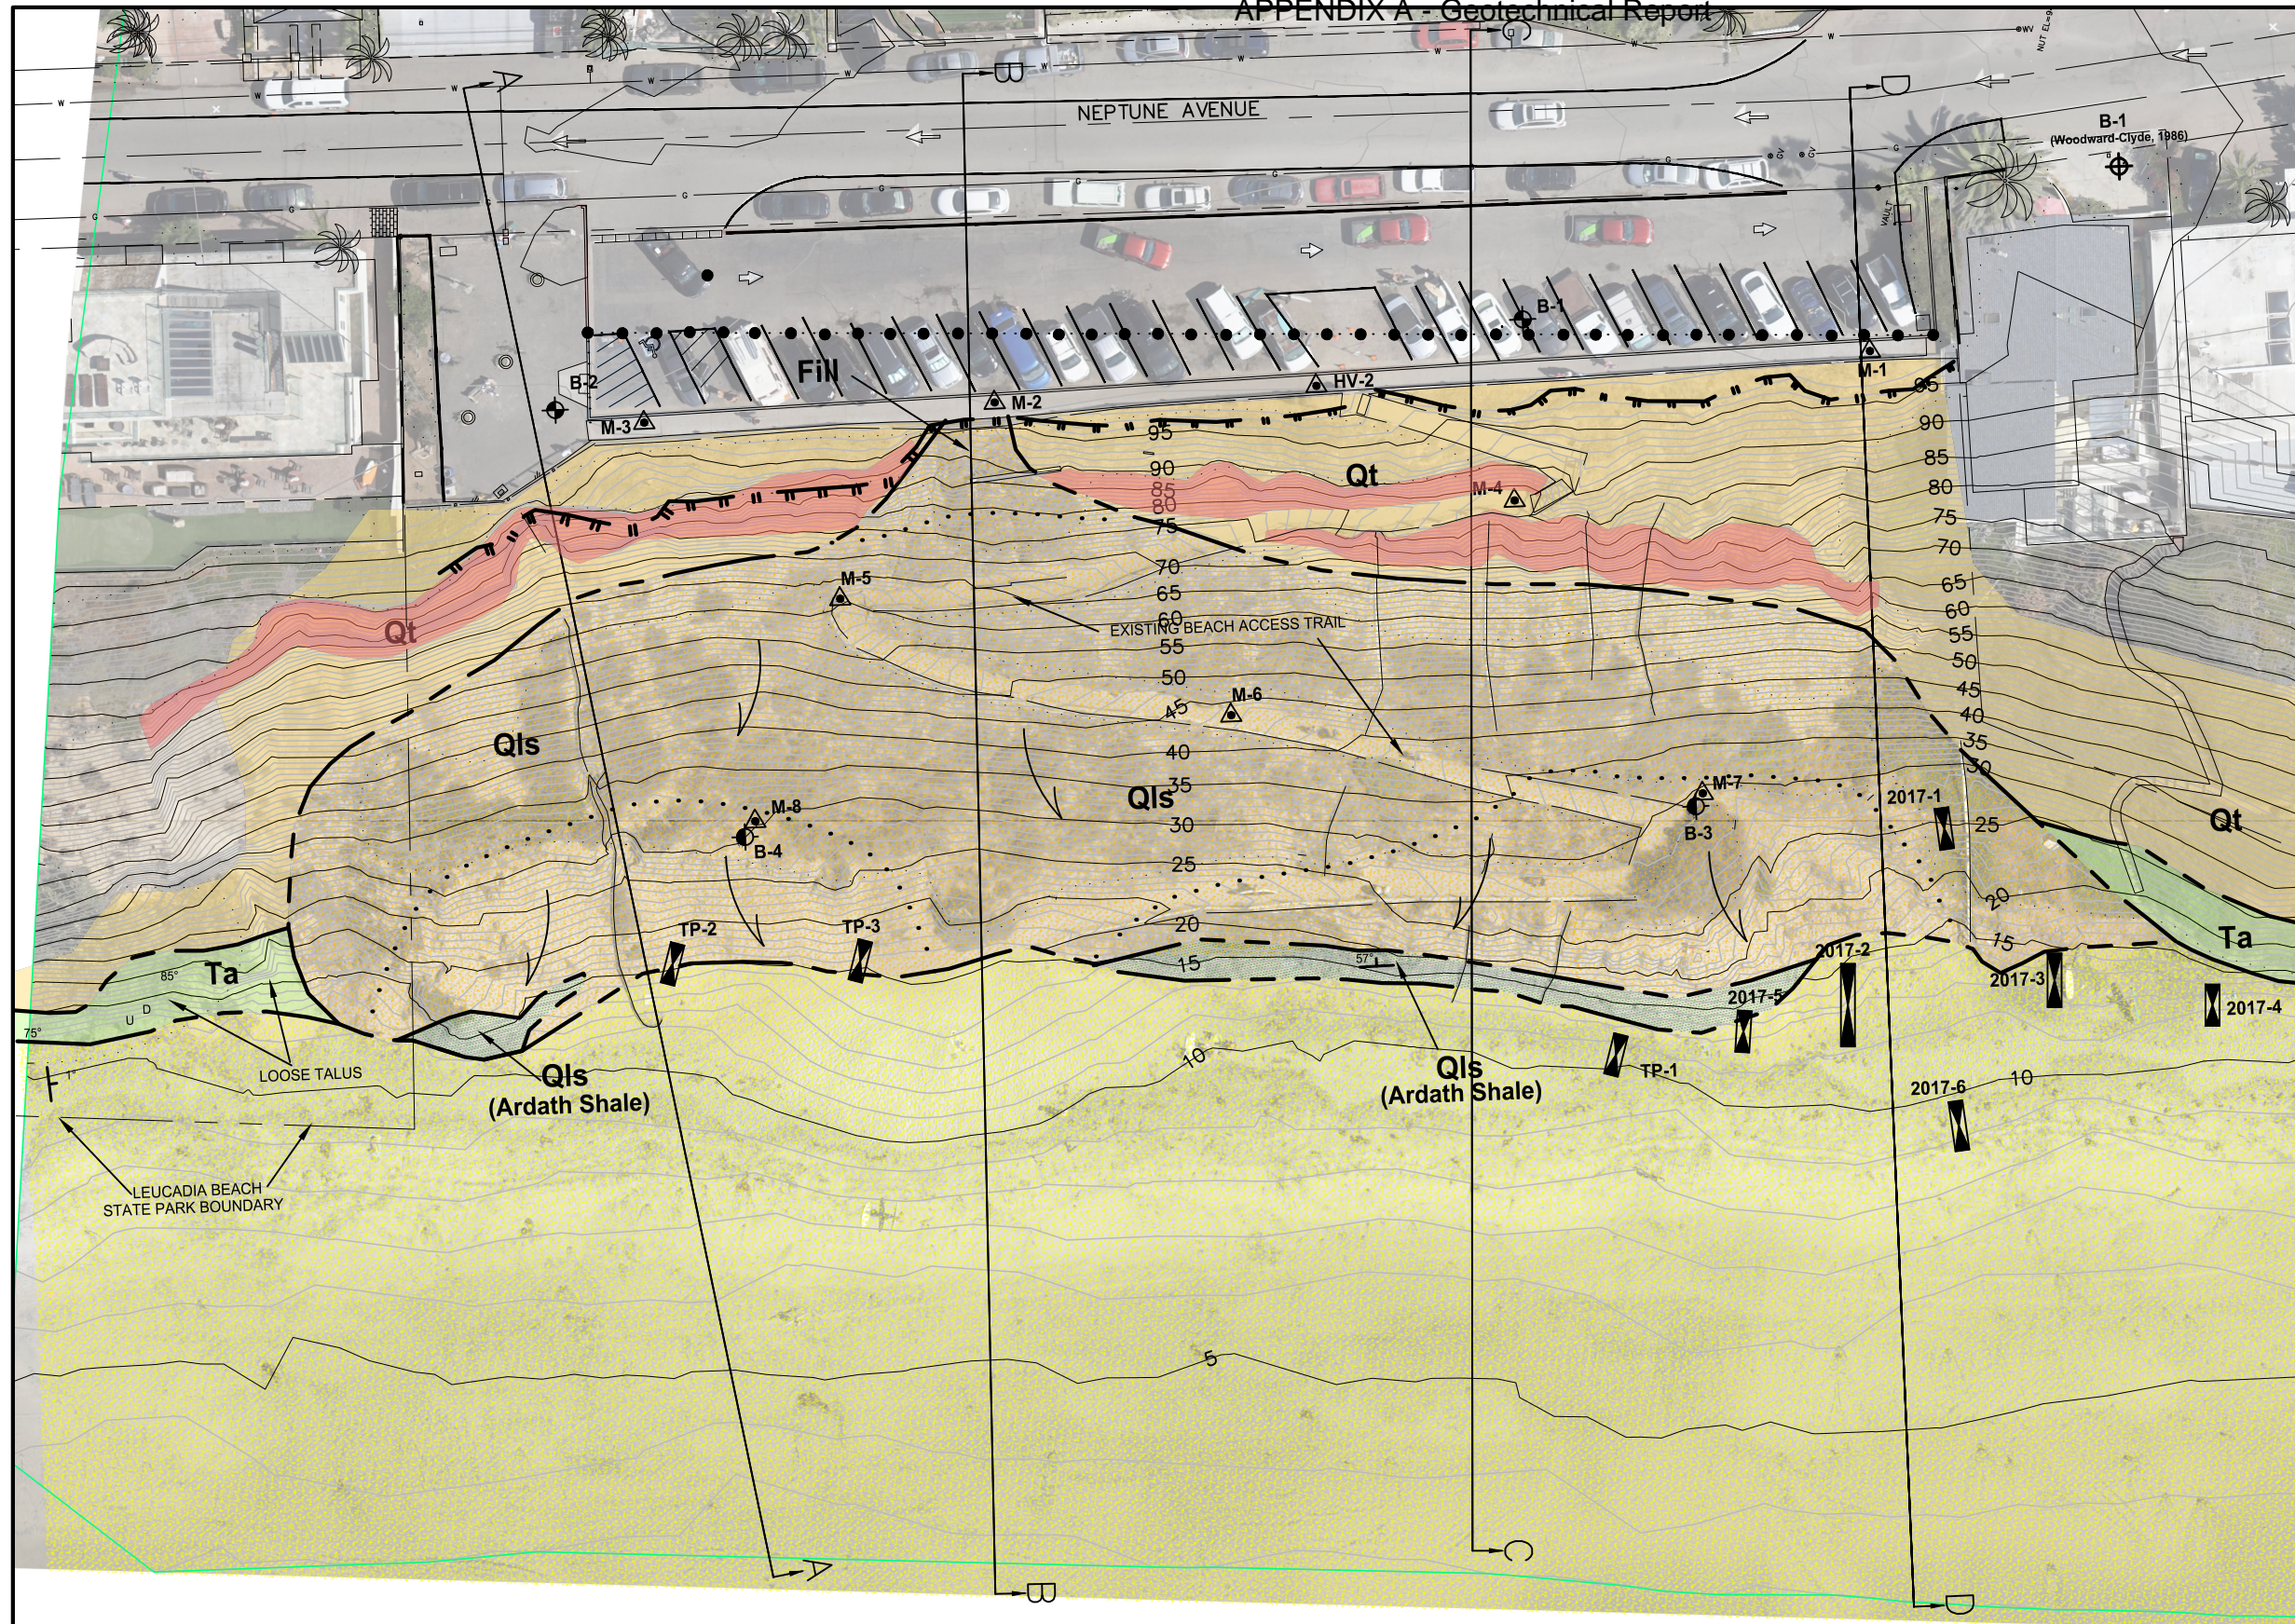
**SITE PLAN AND GEOLOGIC MAP
BEACON'S BEACH ACCESS RECONSTRUCTION PROJECT
ENCINITAS, CALIFORNIA**

Based on engineering analyses and monitoring of the landslide over the years, earthquake shaking is believed to be a likely landslide failure trigger. Slope stability analyses were performed on the same cross sections provided previously (URS, 2003) using updated topography; locations of the sections are shown on Figure 1¹. Factors of safety were analyzed for potential deep landsliding and for upper bluff instability.

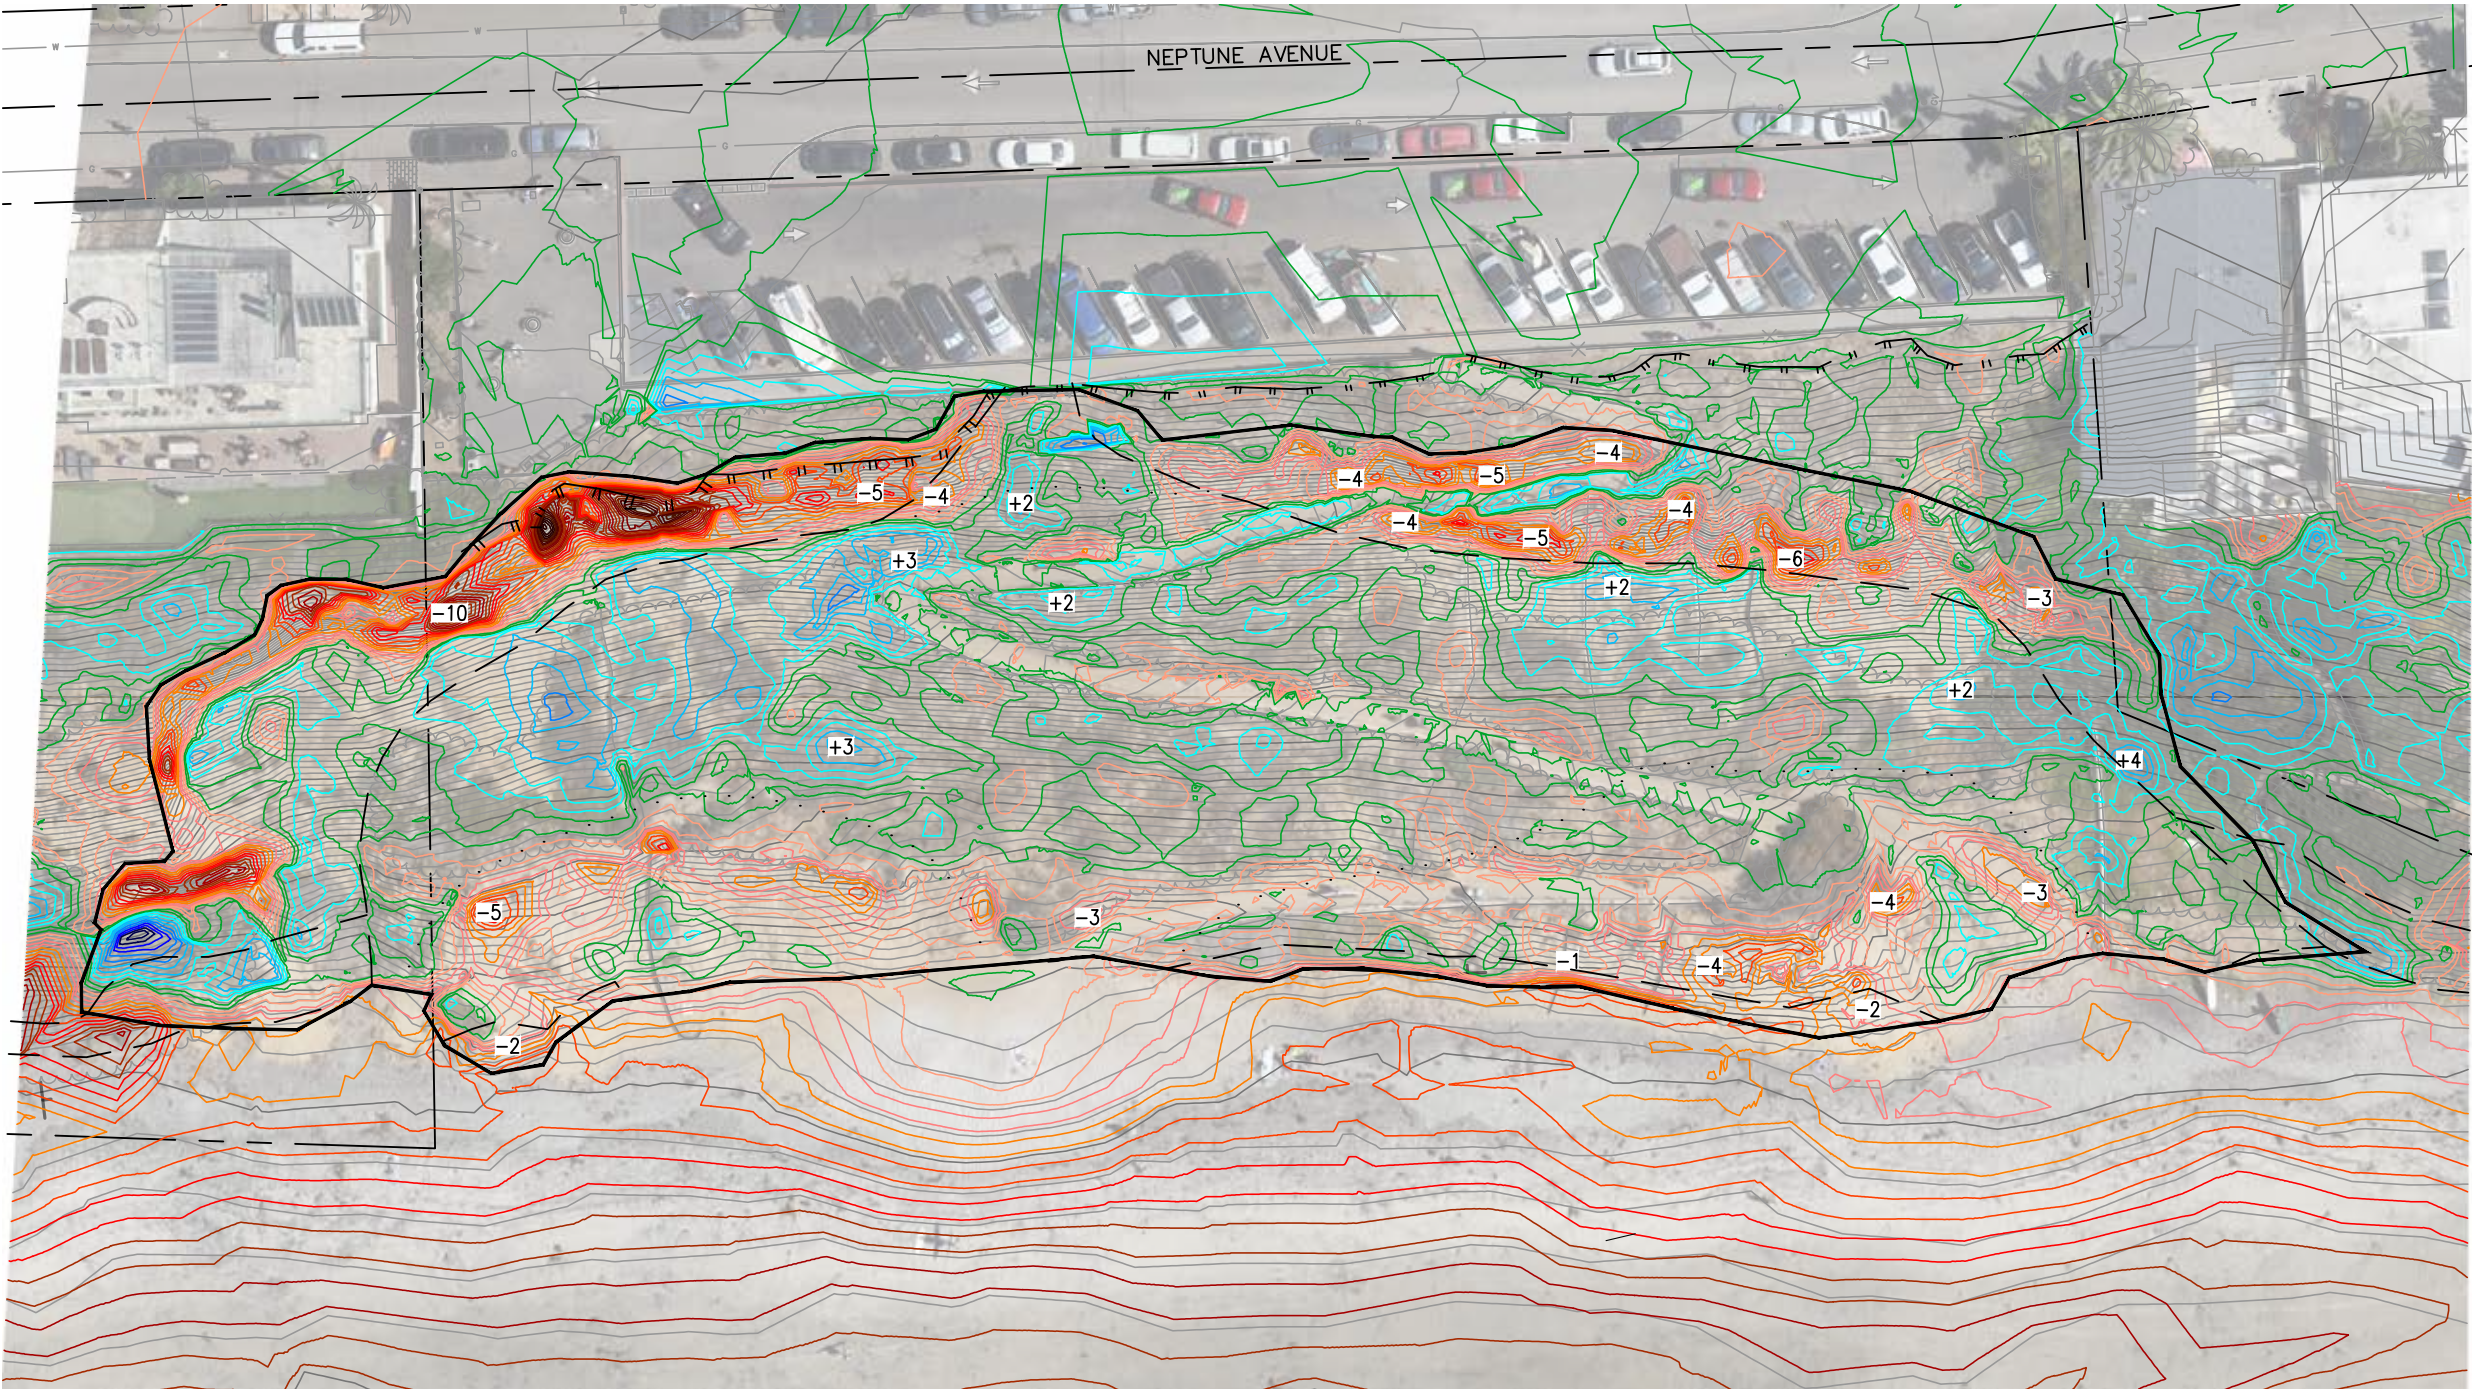
EROSION ASSESSMENT (2002-2017)
BEACON'S BEACH ACCESS RECONSTRUCTION PROJECT
ENCINITAS, CALIFORNIA

To help evaluate the risk of instability due to erosion, site topographic data bases were compiled from surveys in 2002 and repeated in 2017. Figure 2 is a comparison of the 2002 and 2017 topography for the site with the data sets compiled as overlays. The topographic analysis indicates negative changes in ground elevations (i.e., the ground surface has lowered; representing erosion), shown as varying shades of red. Areas of with positive elevation change (the ground surface has gone up) have received subaerial eroded sediment derived from the headscarp (shown in blue). Areas with only small topographic changes, estimated at less than 0.5 feet are shown in green. Labels are shown on the figure for increased clarity.

The topographic analysis indicates, over the past 15 years the upper bluff slope, i.e., the landslide headscarp, has eroded landward between 4 and 5 feet above and below the beach access trail, and more than 10 feet below the north portion of the parking lot⁴. The subaerial (non-marine) erosion rate of the terrace deposits (which underlie and form the oversteepened head scarp slope) ranges

between 0.3 feet per year (about 4-inches per year) and more than 1-foot per year near the upper northerly switch back of the beach access trail. The landslide materials have accumulated a several foot thickness of loose eroded/sloughed sandy material derived from the landslide head scarp.
