Geotechnical Evaluation City Heights Pool 4380 Landis Street San Diego, California

Platt/Whitelaw Architects, Inc. 4034 30th Street | San Diego, California 92104

February 12, 2019 | Project No. 108716001

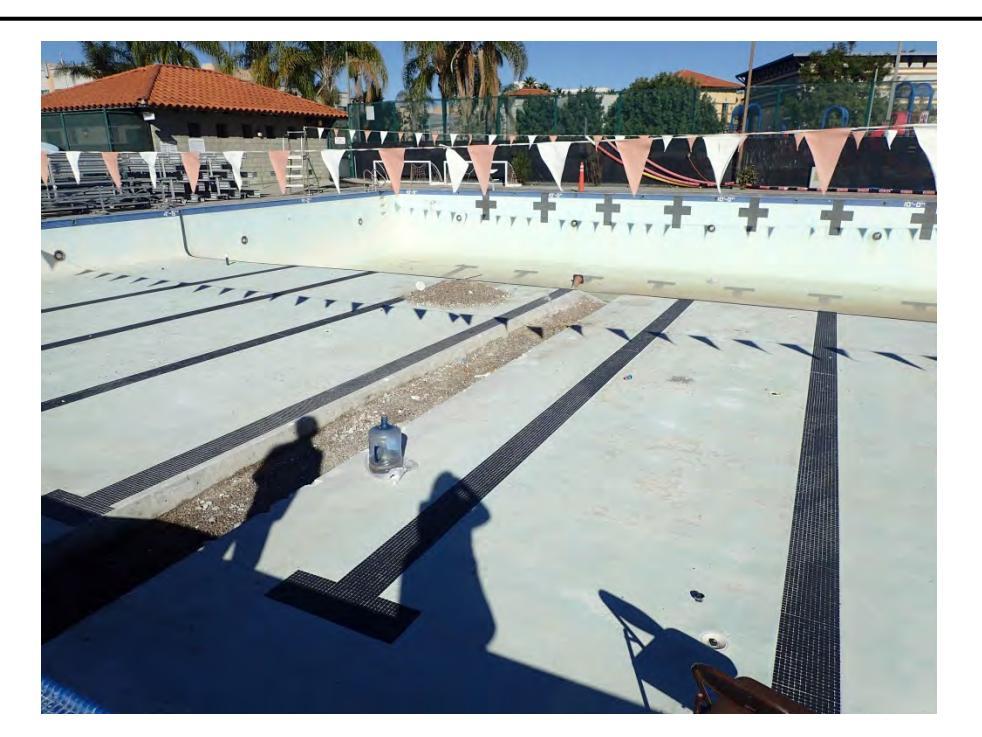
Photograph 1: Drained pool with sawcut area, view to northwest. 12/19/18

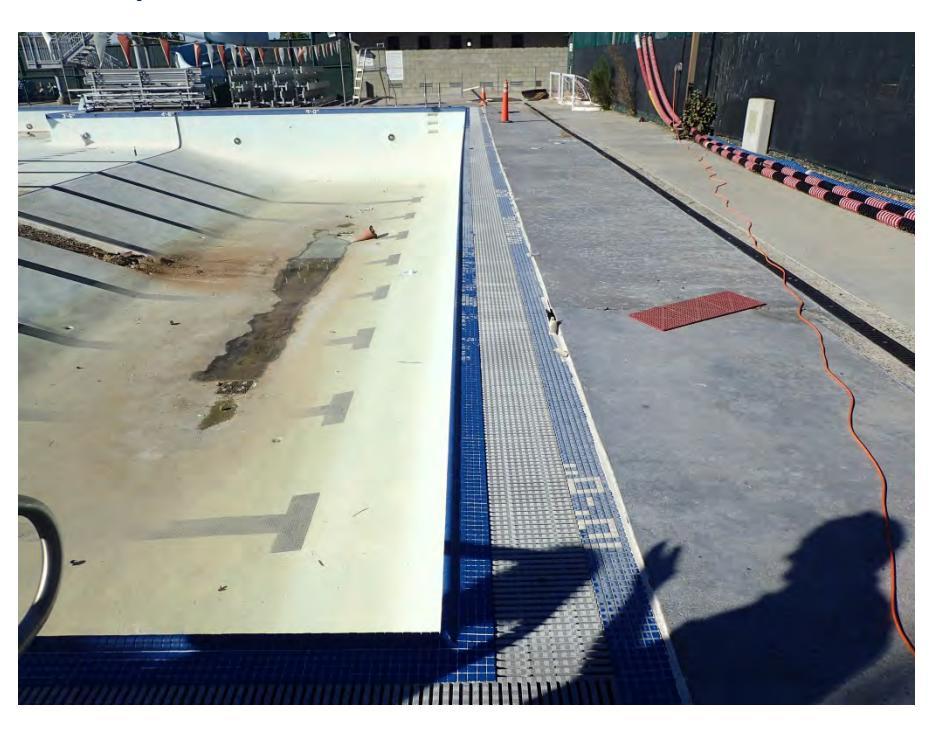
Photograph 2:

Since draining of the pool, bulging of the pool wall was reported on the north side (deep end of the pool). Geocon concludes that the bulging is associated with the change in loading conditions on the pool wall following the removal of the water (Geocon, 2018b). In addition, according to City of San Diego staff, water accumulates at the bottom of the pool and is pumped out each week. This condition also occurred after draining the nearby tot pool. Water has also recently been observed seeping from the pool lights.

North side of pool, view to west. Pool wall exhibits bowing. 12/19/18

Detailed design plans for the existing pool were not available for our review. Based on our geotechnical evaluation, we recommend that the pool be reconstructed with a new shell. As such, we are providing the following recommendations.

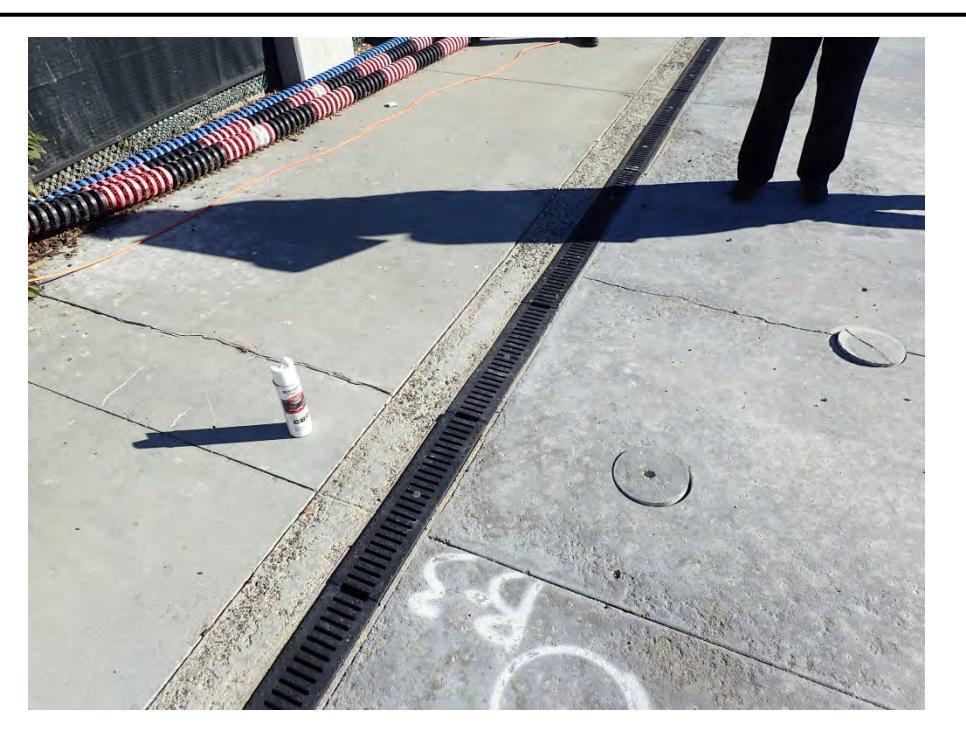
Photograph 3: Concrete deck on north side of pool. Pool deck is cracked. Concrete cores in view are by others. 12/19/18

For pool decking and general site sidewalks, to reduce the potential for shrinkage cracking, the pool decking should be 5 inches thick and should be reinforced with No. 3 reinforcing bars placed at 18 inches on-center (both ways). We recommend that crack control joints be provided at an interval of every 6 feet or less to help reduce the potential for distress due to soil movement and concrete shrinkage. As a further measure to reduce cracking of pool decking, the subgrade soils to a depth of approximately 12 inches below the pool decking and general sidewalks should be compacted to a relative compaction of 90 percent or more in accordance with the latest edition of ASTM D 1557 at moisture contents generally above the laboratory optimum. The subgrade soils should be shaped to provide a minimum gradient of one percent away from the pool shell and towards a subsurface drainage system.

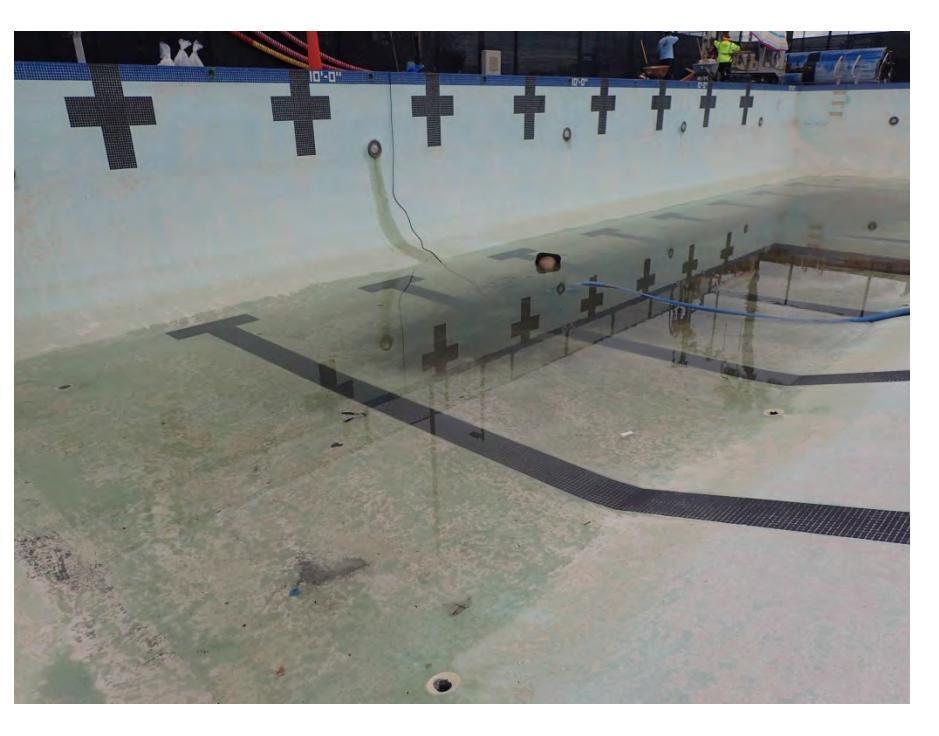
Photograph 4:

Water in deep end of the pool (north side). A pump was being used to remove the water. 01/15/19

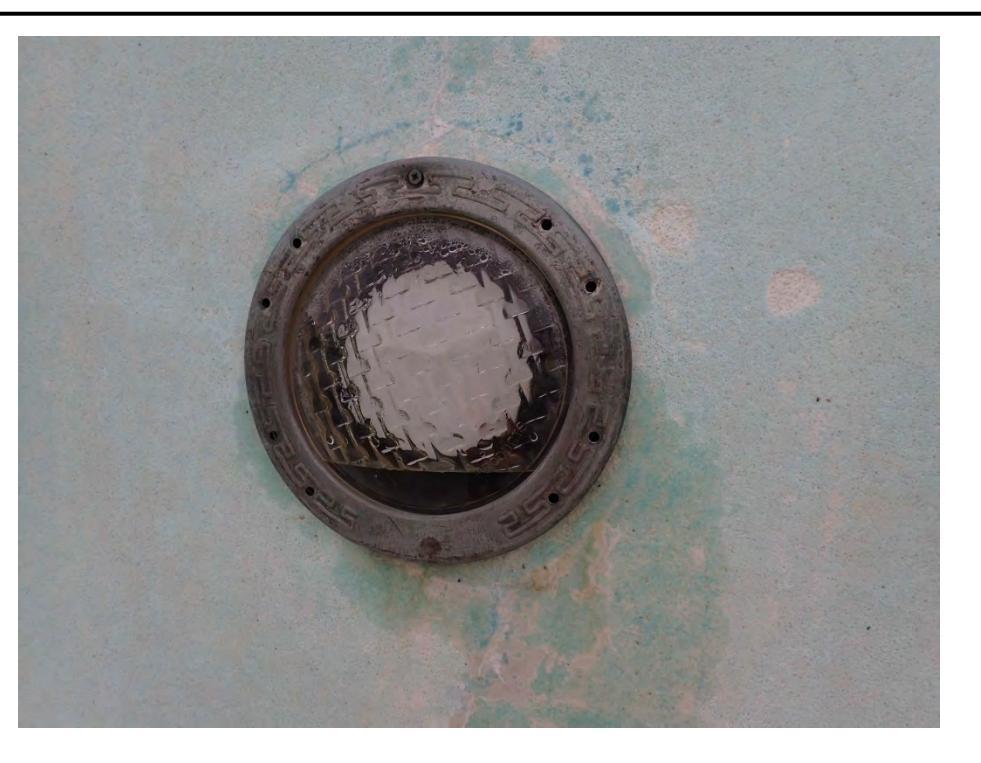
Photograph 5: Water within pool light with seepage at corner. 01/15/19

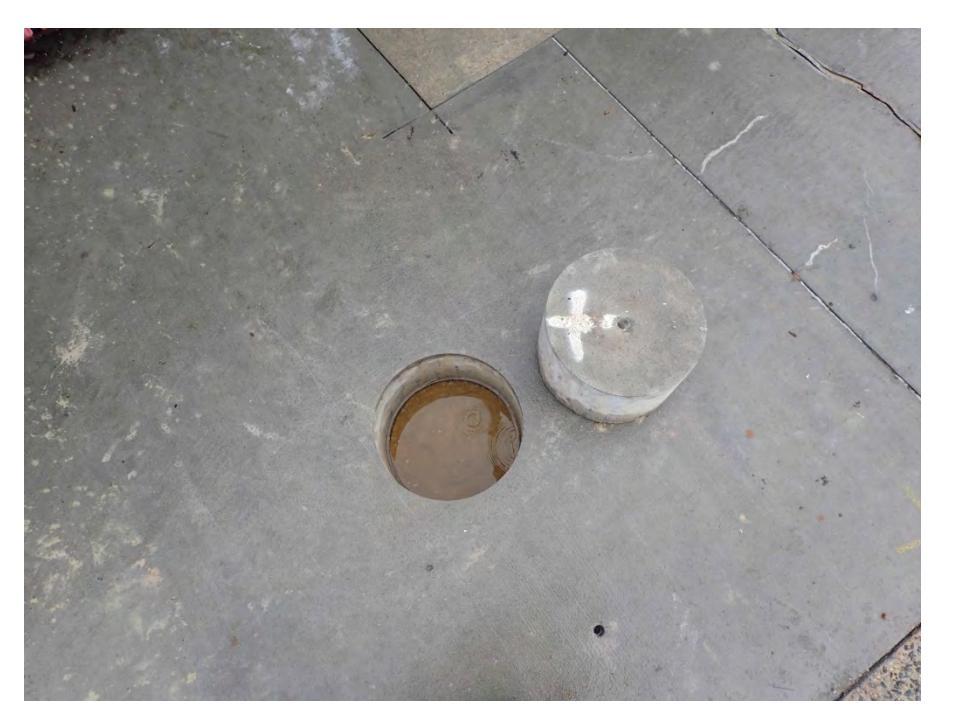
Photograph 6:

Groundwater was not encountered at the time of our subsurface exploration. However, seepage was encountered within the fill in borings B-2 and B-3. Seepage in boring B-2 was generally heavy and standing water was observed in the cored concrete pool deck prior to drilling of the boring. Reported extensive leaks in piping at the site likely contributed to the observed seepage. According to our review of readily available data from the Geotracker (2018) website, groundwater is anticipated at depths greater than 100 feet. Existing utility trench lines may act as conduits for perched water conditions and seepage should be anticipated. Fluctuations in the groundwater level and perched conditions may occur due to variations in ground surface topography, subsurface geologic conditions and structure, rainfall, irrigation, and other factors.

Standing water after pavement core at B-2. 01/15/19
