**REPORT OF GEOTECHNICAL INVESTIGATION  
PARKING STRUCTURE NO. 4  
MIRAMAR COLLEGE CAMPUS  
10440 BLACK MOUNTAIN ROAD  
SAN DIEGO, CALIFORNIA  
SAN DIEGO COUNTY  
APN NO. 318-120-03-00**

Project No. SD437

**SUBJECT: GEOTECHNICAL INVESTIGATION**  
**Parking Structure No. 4**  
**Miramar College Campus**  
**10440 Black Mountain Road**  
**San Diego, California**  
**San Diego County**  
**APN NO. 318-120-03-00**

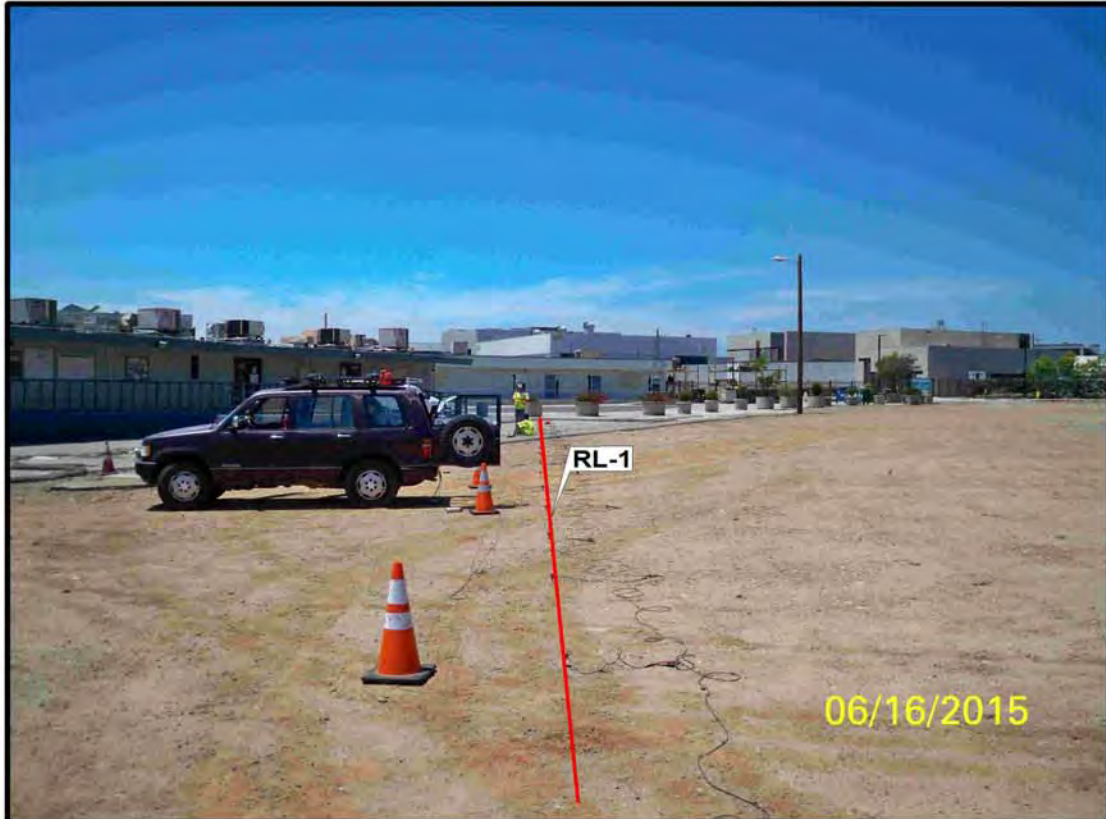
## SITE PHOTOGRAPH

Proposed Parking Structure, Miramar College  
San Diego, California

Our scope of services included the performance of a refraction microtremor (ReMi) survey at a preselected area at the project site (Figure 2). The ReMi technique uses recorded surface waves (specifically Rayleigh waves) that are contained in background noise to develop a Shear-wave velocity profile of the study area down to a depth, in this case, of approximately 100 feet. The ReMi survey included the use of a 24-channel Geometrics Geode seismograph and 24 4.5-Hz vertical component geophones. The geophones were spaced 10 feet apart for a line length of 230 feet. Fifteen records, each 30 seconds long, were recorded and then downloaded to a computer. The data were later processed using SeisOpt® ReMi™ software. Figure 3 depicts the general site conditions in the survey area.
