PRELIMINARY GEOTECHNICAL INVESTIGATION AND INFILTRATION FEASIBILITY STUDY

EASTLAKE HIGH SCHOOL

**Eastlake Parkway
Chula Vista, California**

Prepared By:
SCST, Inc.
6280 Riverdale Street
San Diego, California 92120

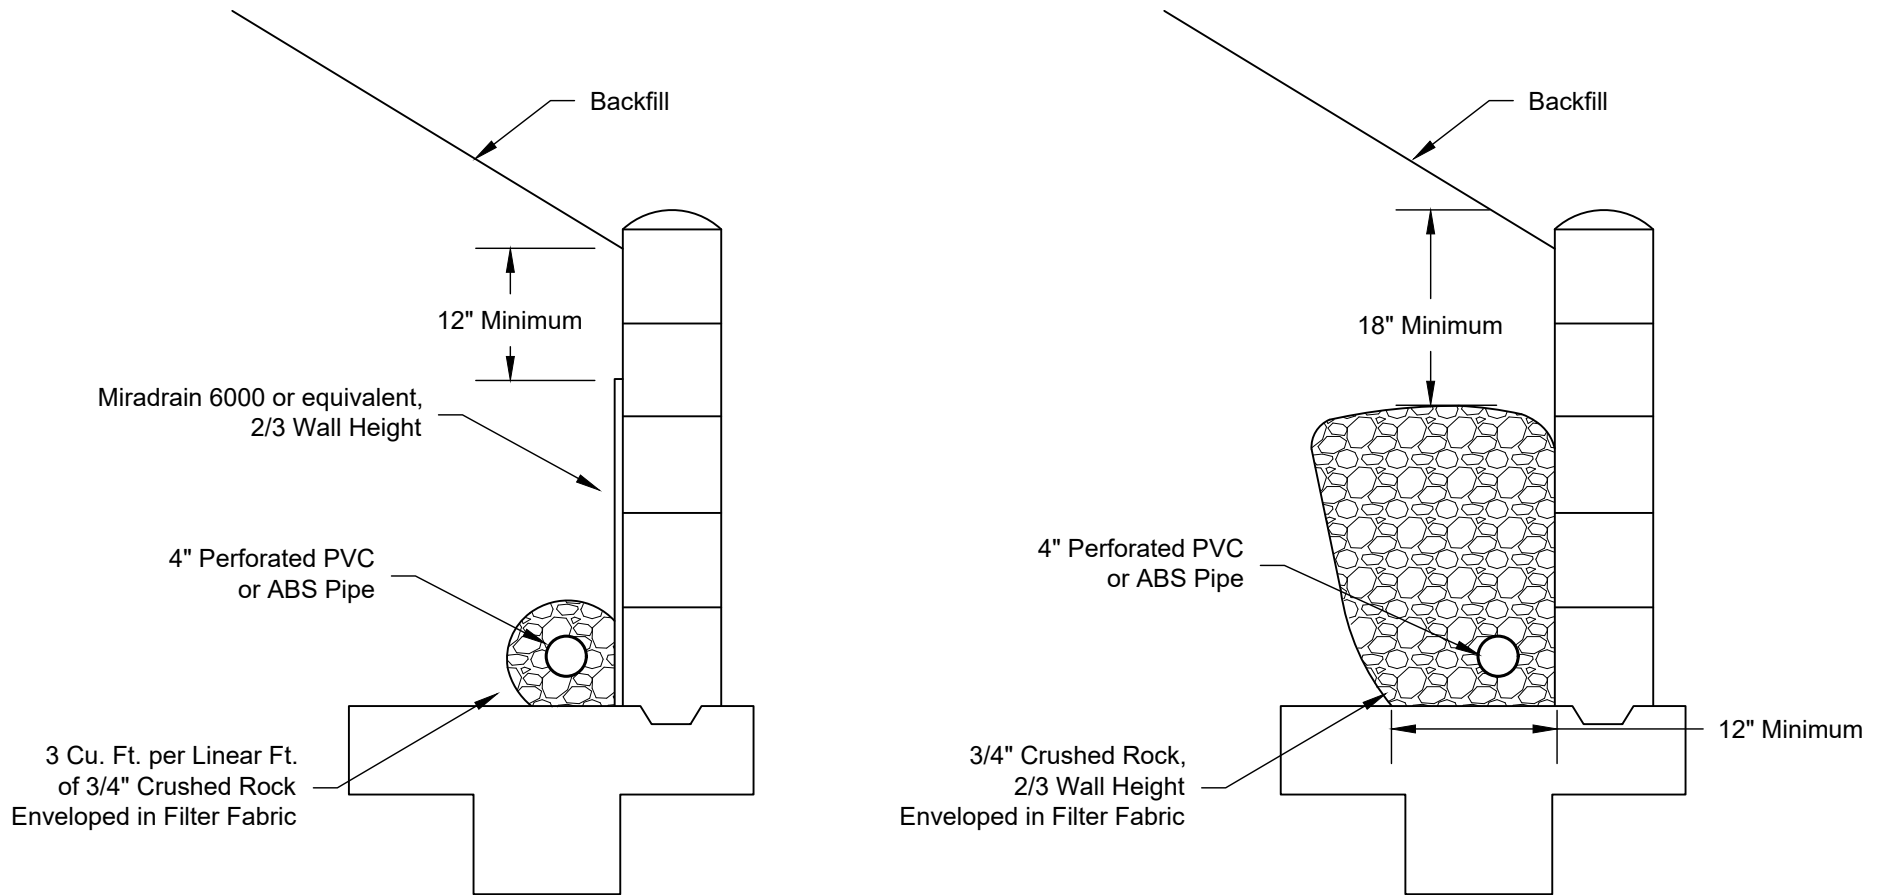
4

- 1) Dampproof or waterproof back of wall following architect's specifications.
- 2) 4" minimum perforated pipe, SDR35 or equivalent, holes down, 1% fall to outlet. Provide solid outlet pipe at suitable locations.
- 3) Drain installation and outlet connection should be observed by the geotechnical consultant.

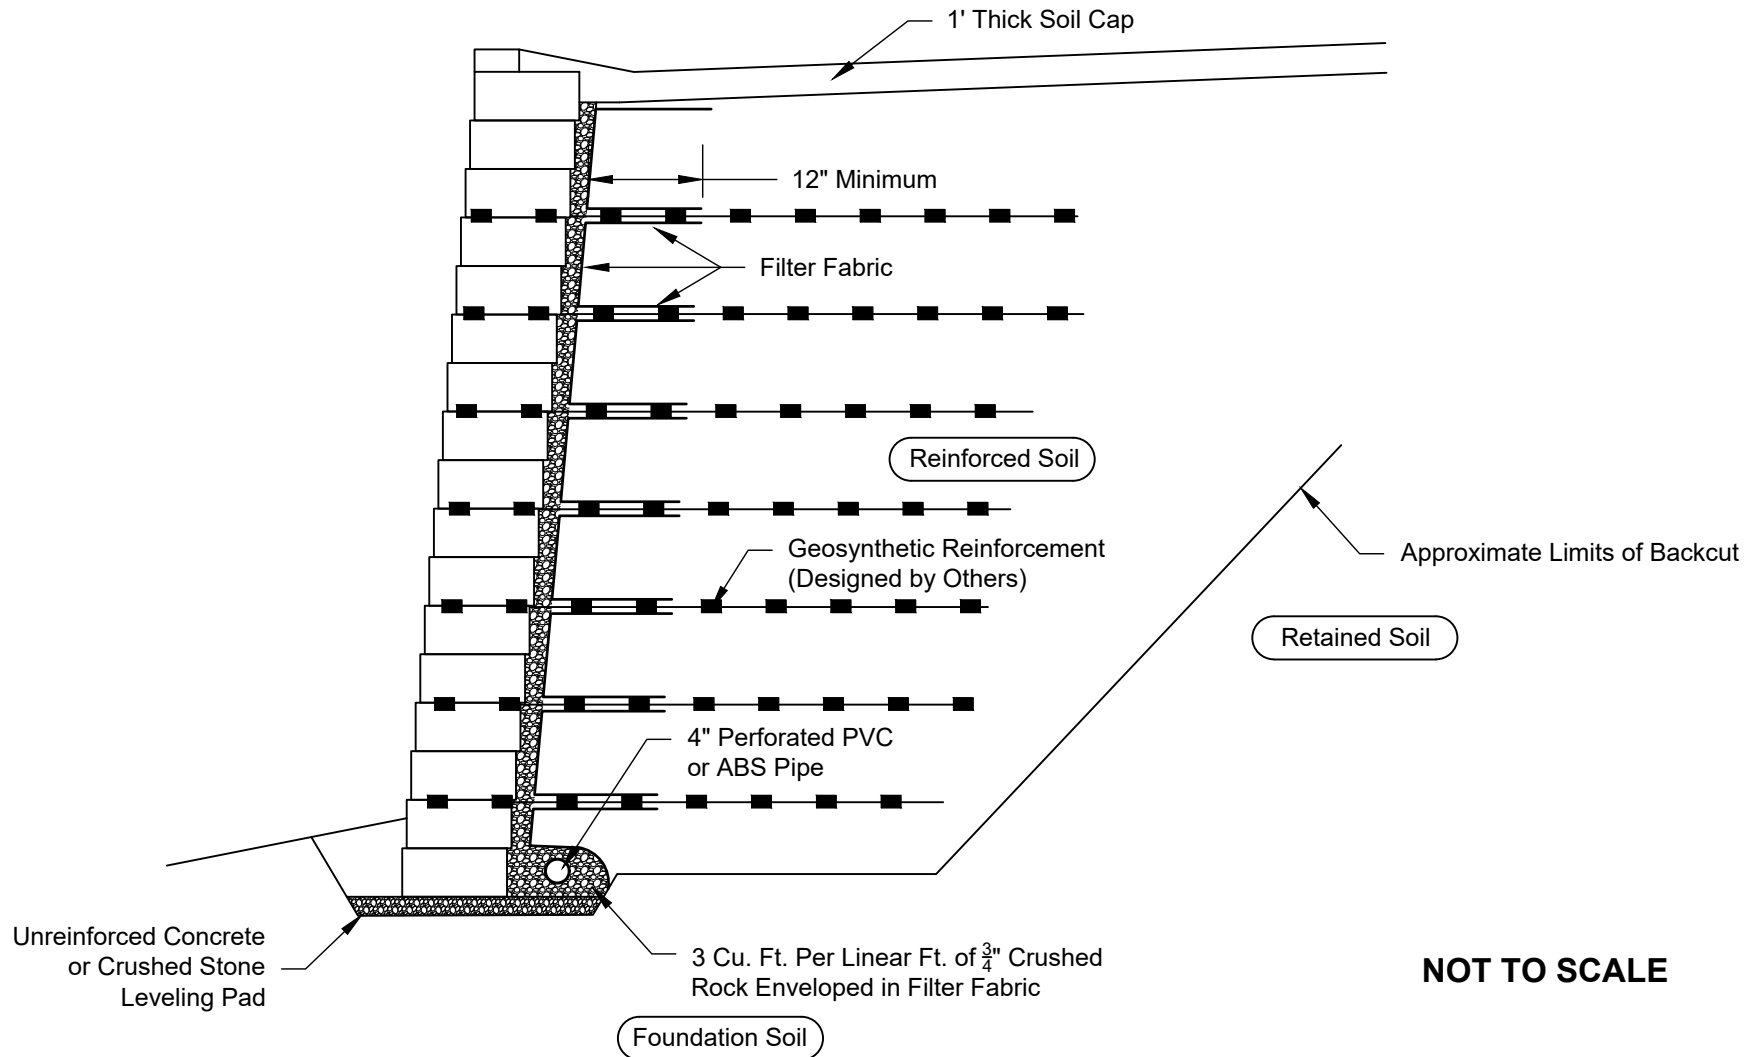
- 1) Backcut as recommended by the geotechnical report or field evaluation
- 2) Additional drain at excavation backcut may be recommended base on conditions obsewrved during construction.
- 3) Filter fabric should be installed between crushed rock and soil. Filter fabric should consist of Mirafi 140N or equivalent. Filter fabric should be overlapped approximately 6 inches.
- 4) Perforated pipe should outlet through a solid pipe to an appropriate gravity outfall. Perforated pipe and outlet pipe should have a fall of at least 1%.

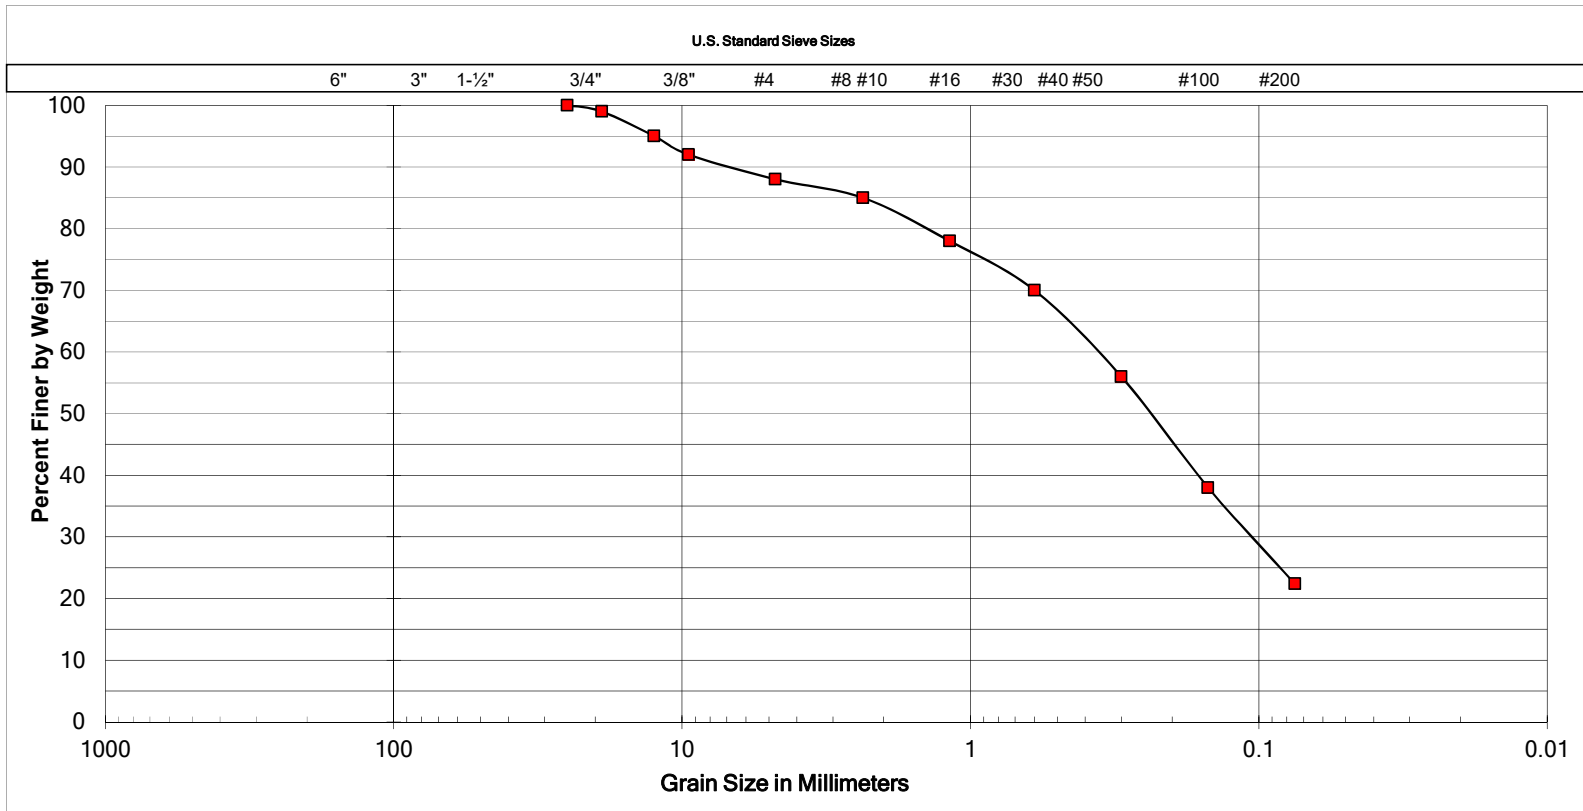
Eastlake High School Chula Vista, California	
By: EMW	Date: October, 2018
Job Number: 180335P4.1-2	Figure: II-1

SAMPLE LOCATION
B-1 at ½ to 2½ feet

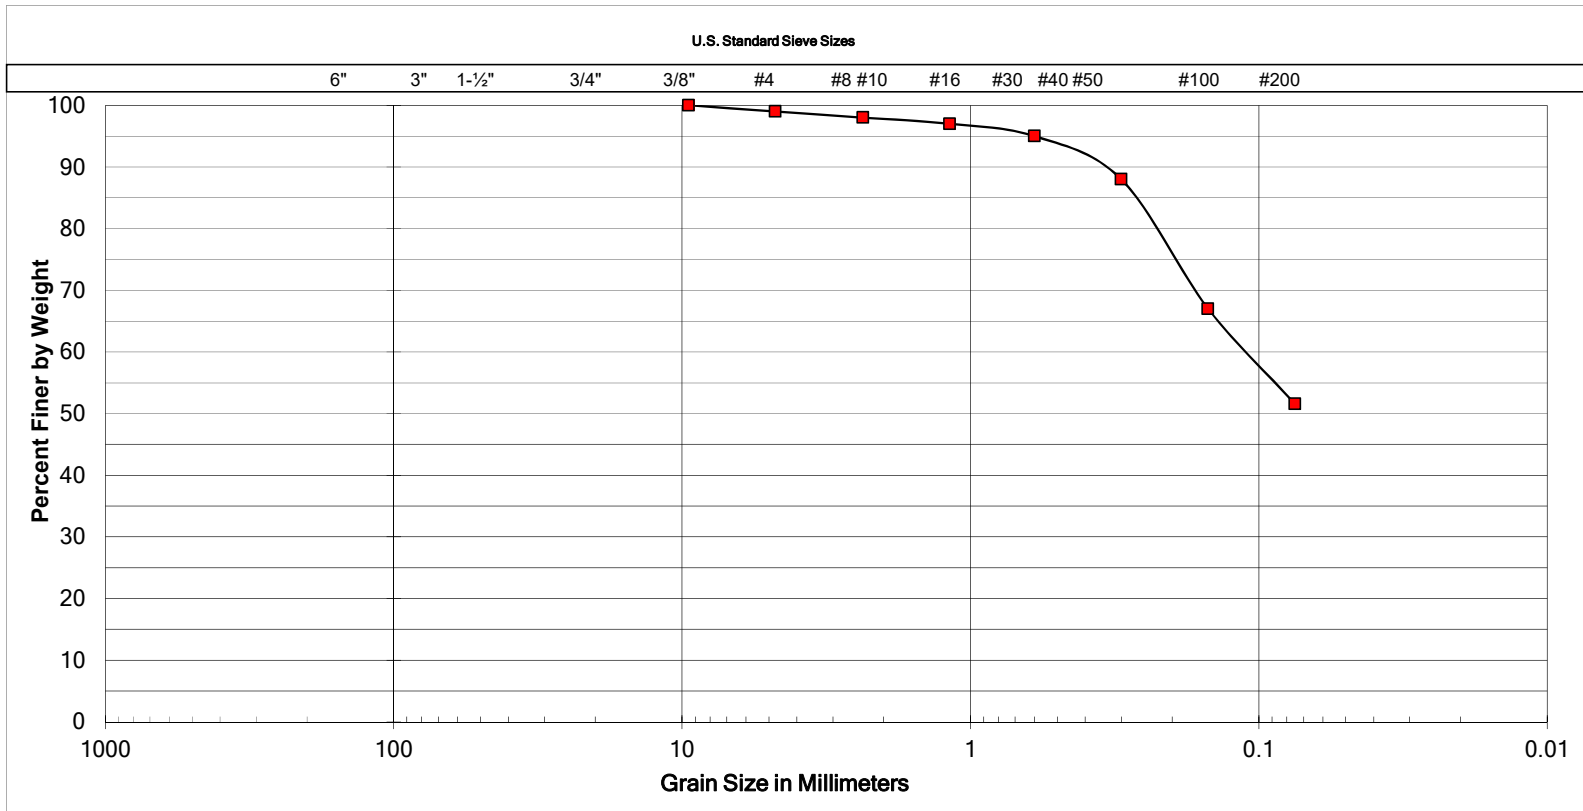
Eastlake High School Chula Vista, California	
By: EMW	Date: October, 2018
Job Number: 180335P4.1-2	Figure: II-2

SAMPLE LOCATION
B-2 at 1/2 to 5 feet

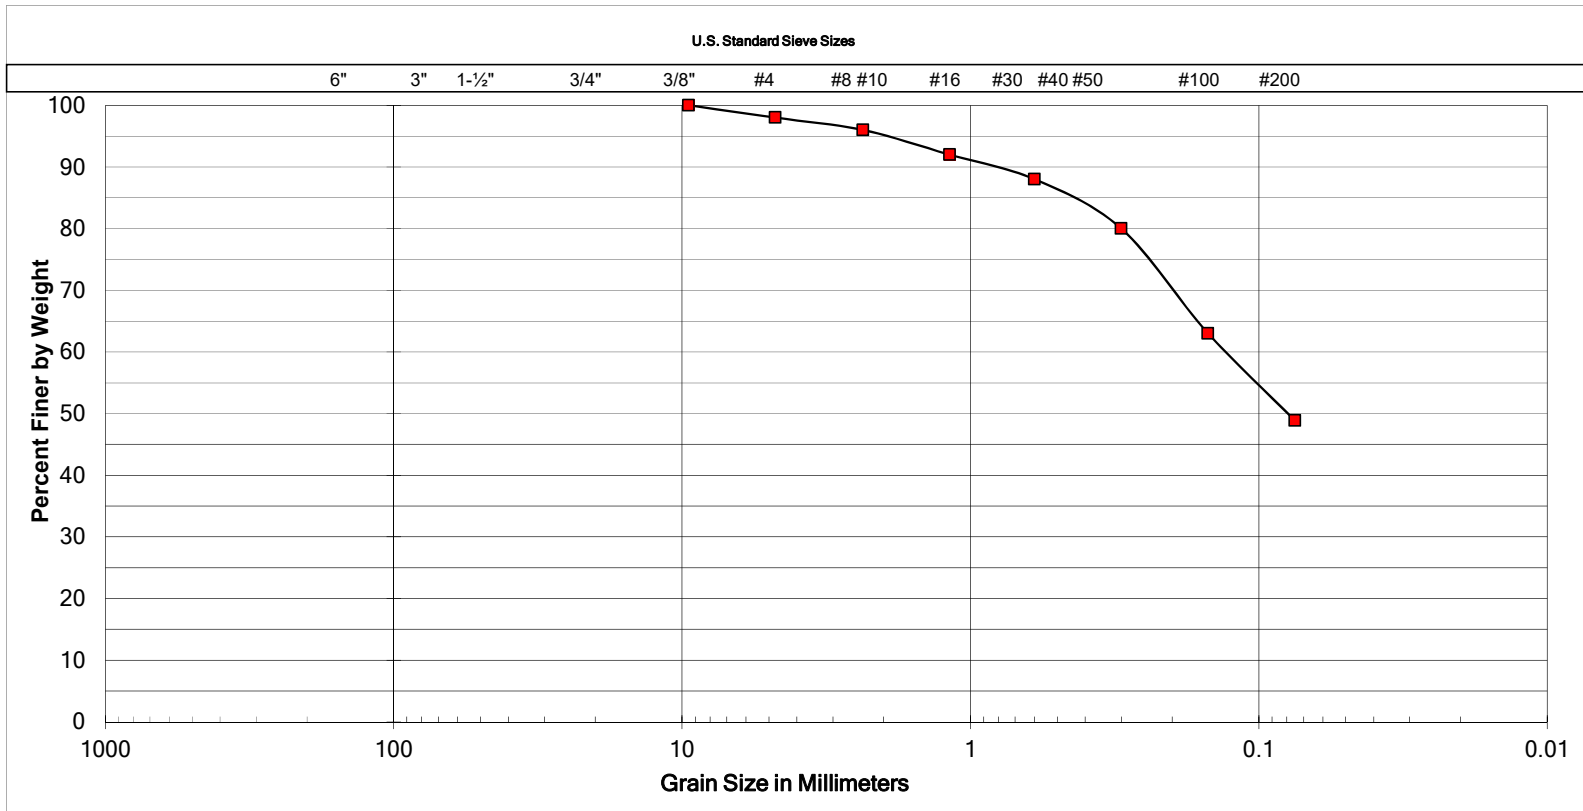
Eastlake High School Chula Vista, California	
By: EMW	Date: October, 2018
Job Number: 180335P4.1-2	Figure: II-3

SAMPLE LOCATION
B-3 at 4 to 5 feet

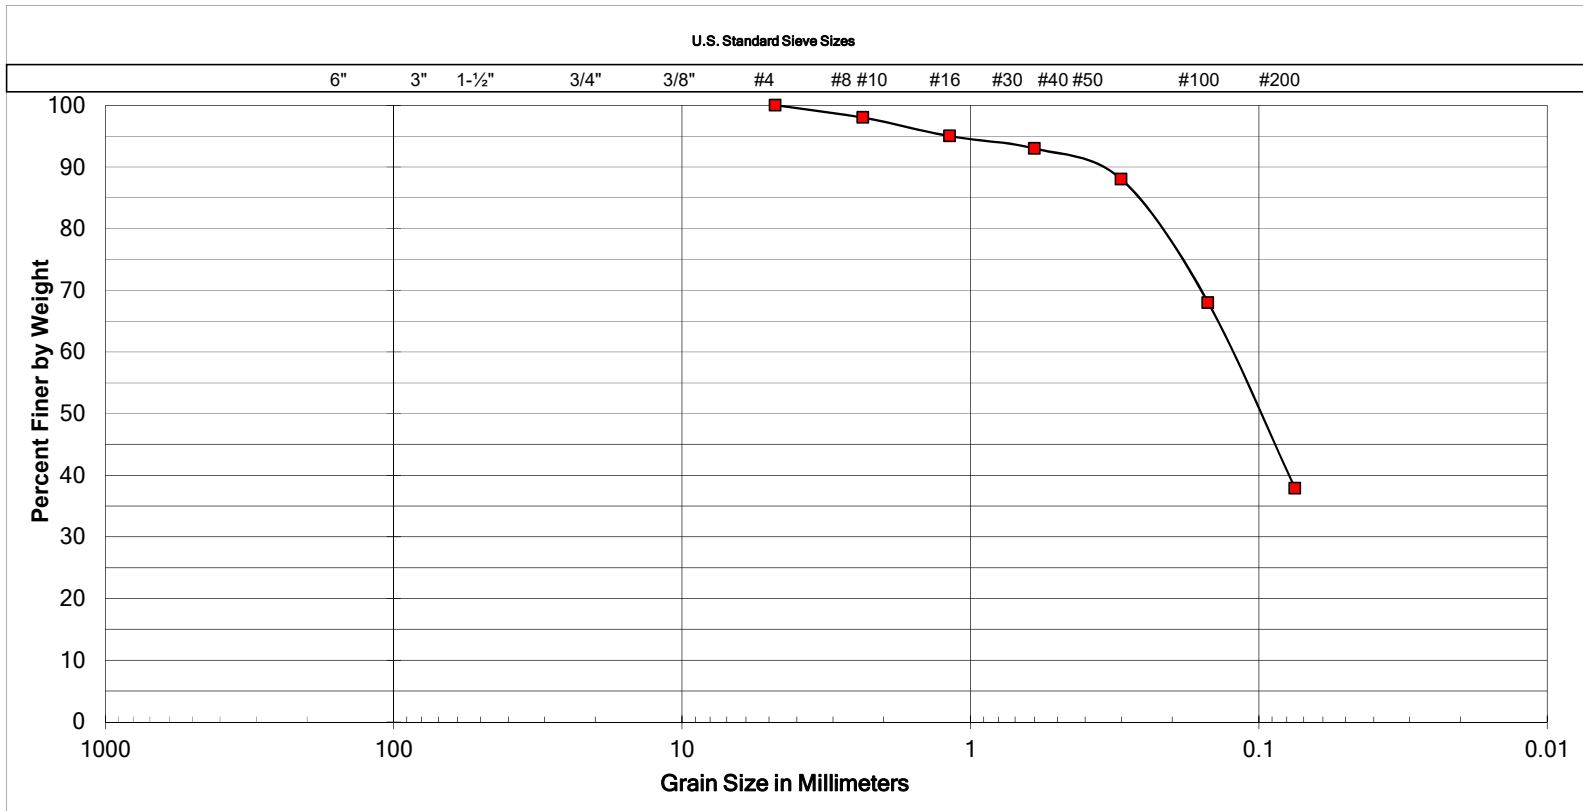
Eastlake High School Chula Vista, California	
By: EMW	Date: October, 2018
Job Number: 180335P4.1-2	Figure: II-4

SAMPLE LOCATION
B-5 at 2 to 5 feet

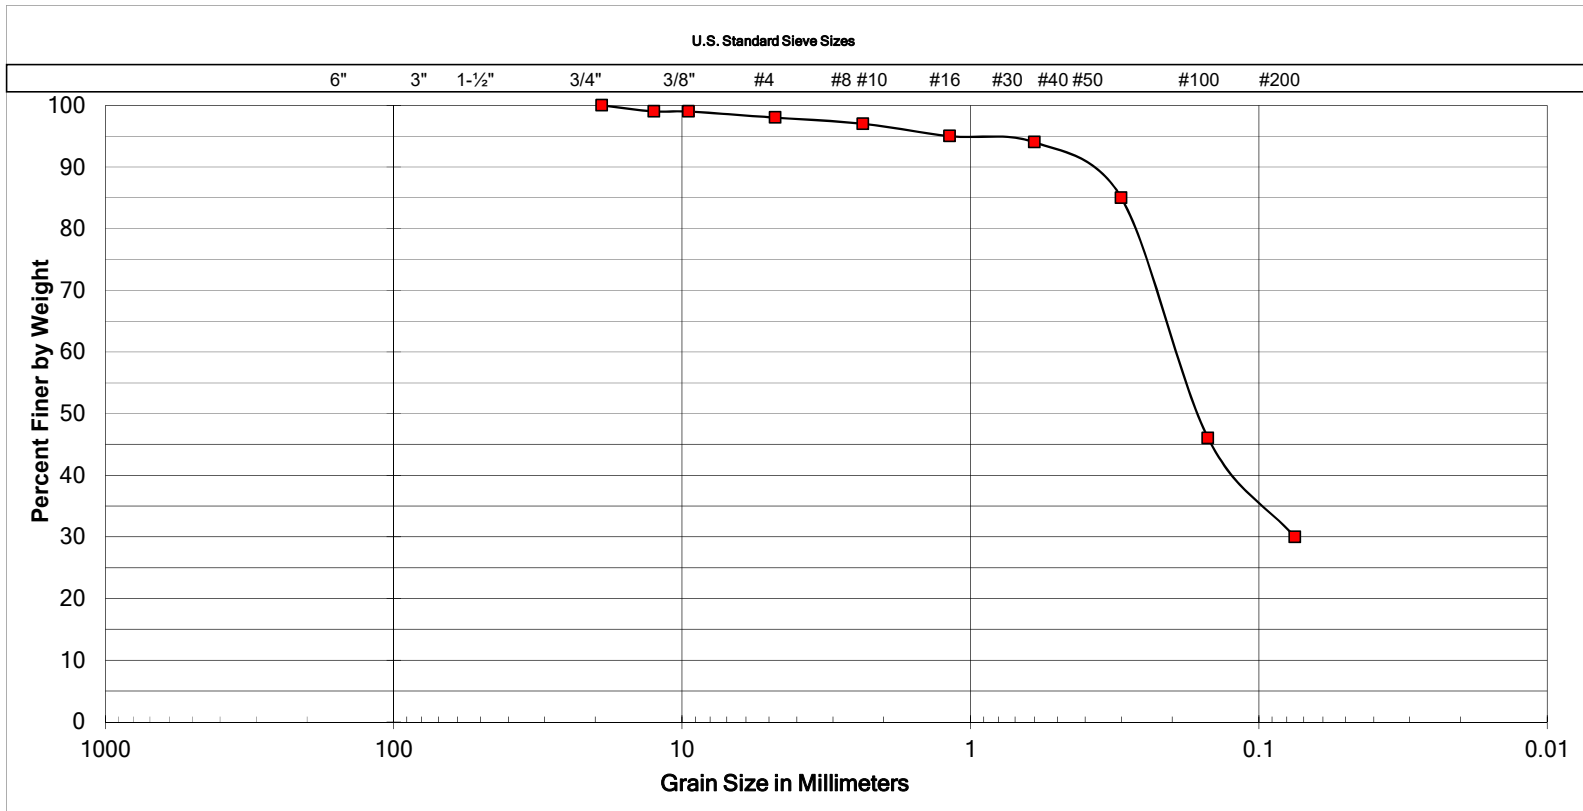
Eastlake High School Chula Vista, California	
By: EMW	Date: October, 2018
Job Number: 180335P4.1-2	Figure: II-5

SAMPLE LOCATION
B-6 at ½ to 2½ feet

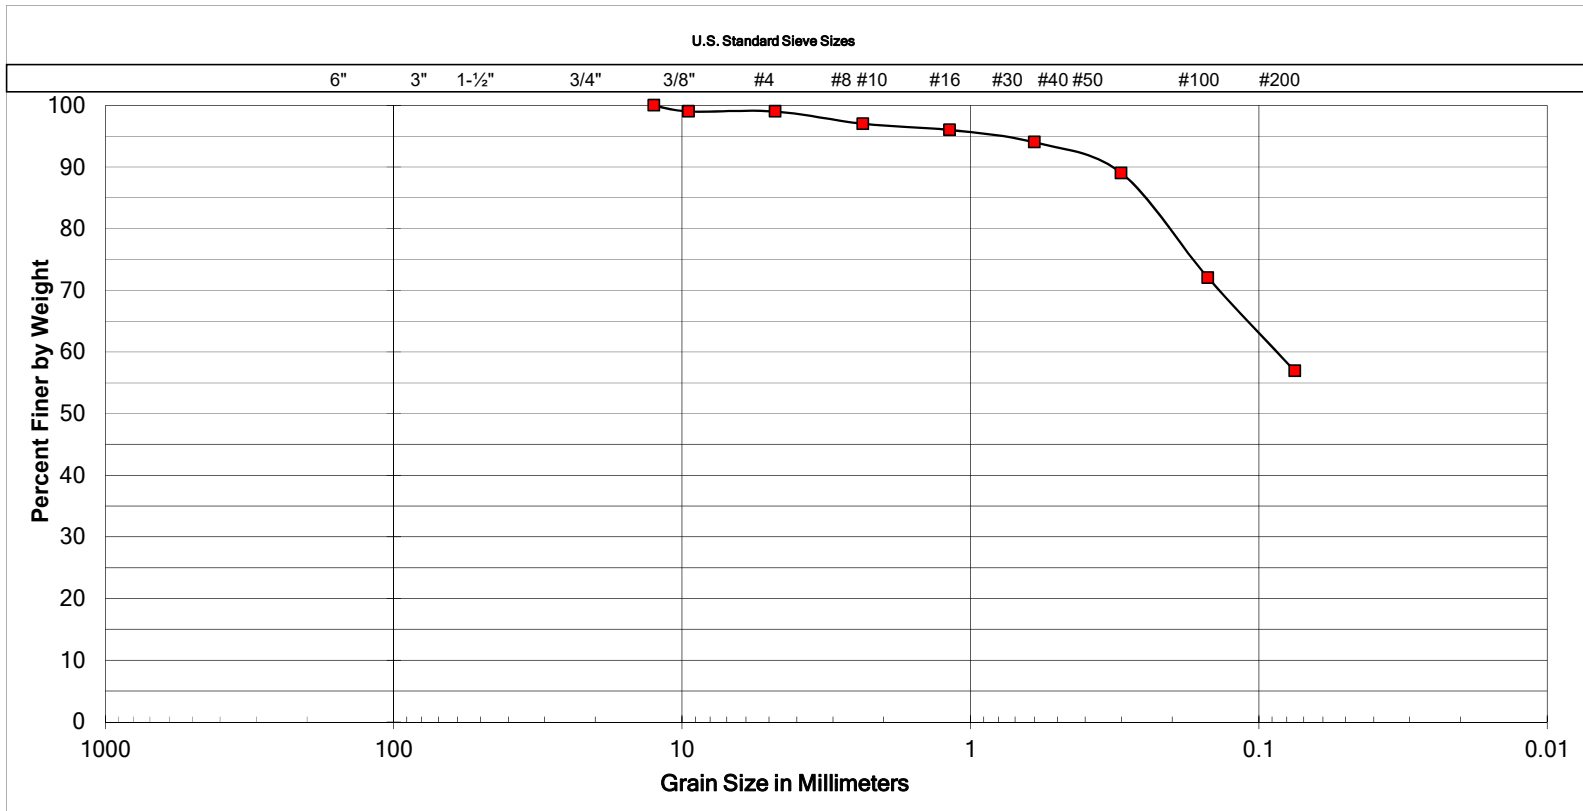
Eastlake High School Chula Vista, California	
By: EMW	Date: October, 2018
Job Number: 180335P4.1-2	Figure: II-6

SAMPLE LOCATION
B-7 at ½ to 5 feet

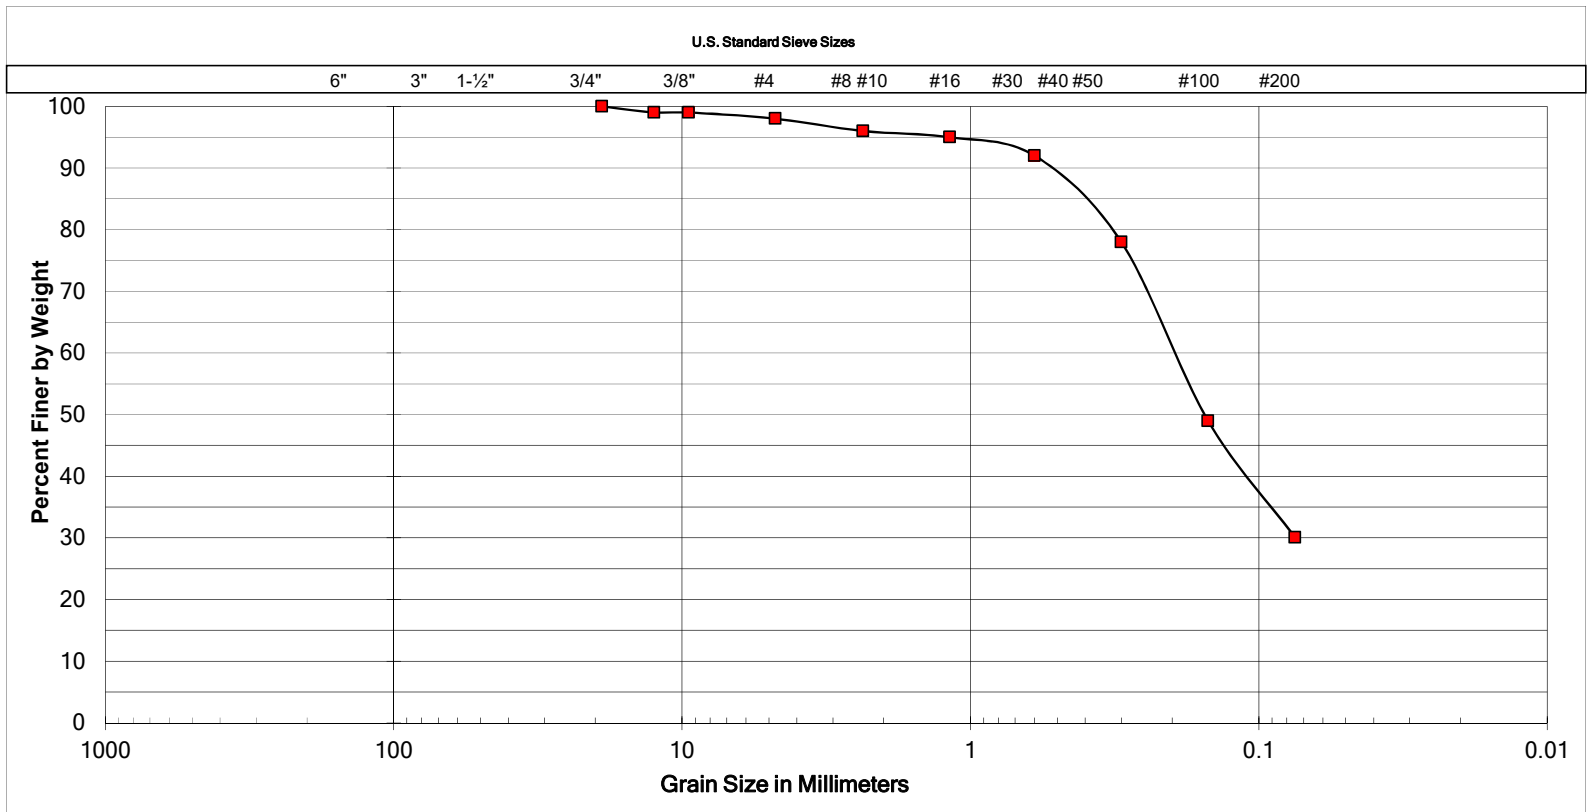
Eastlake High School Chula Vista, California	
By: EMW	Date: October, 2018
Job Number: 180335P4.1-2	Figure: II-7

SAMPLE LOCATION
B-8 at 4 to 5 feet

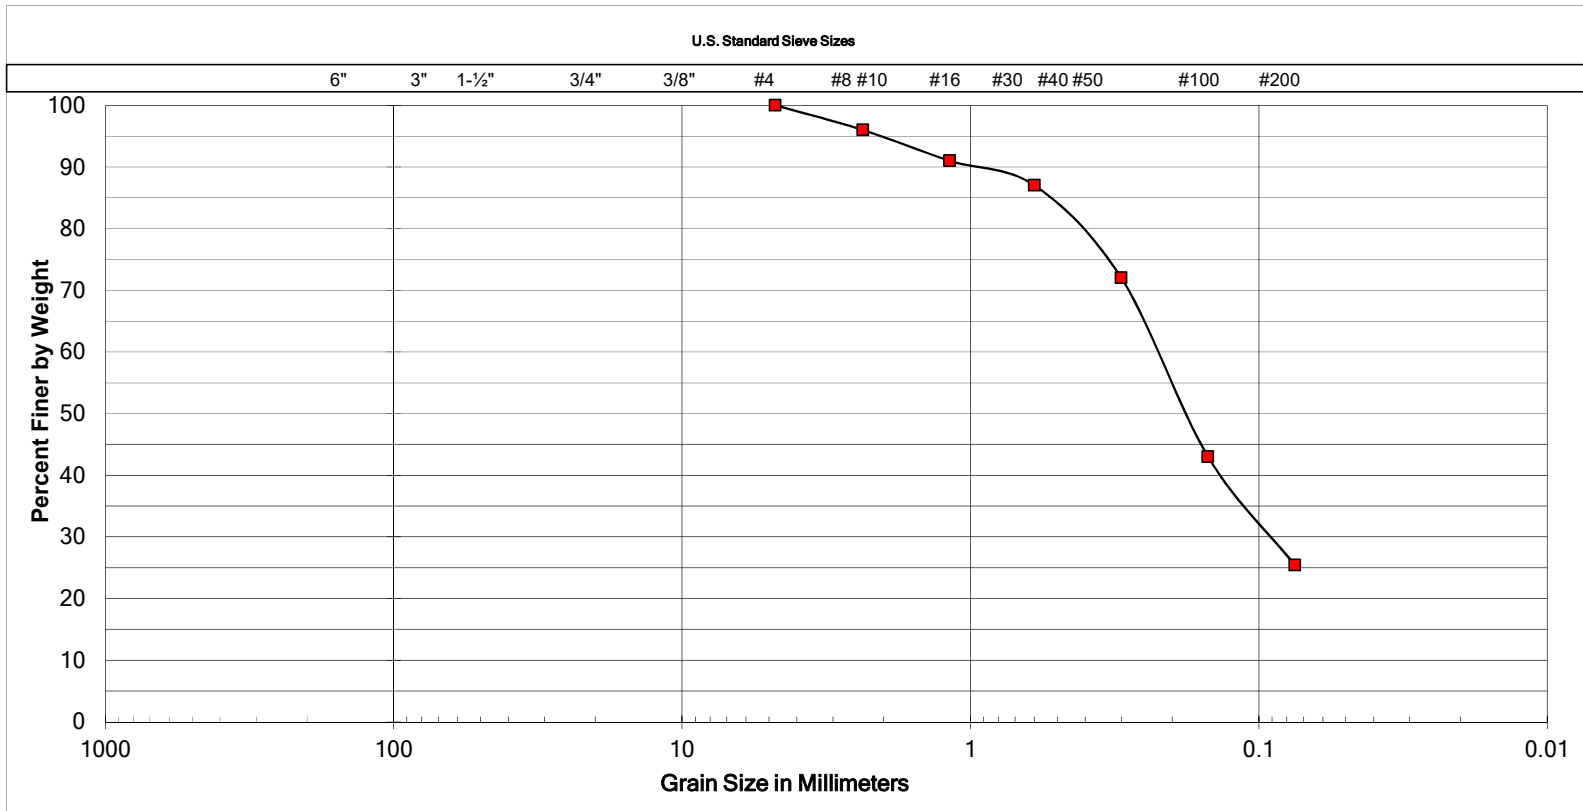
Eastlake High School Chula Vista, California	
By: EMW	Date: October, 2018
Job Number: 180335P4.1-2	Figure: II-8

SAMPLE LOCATION
B-9 at ½ to 5 feet

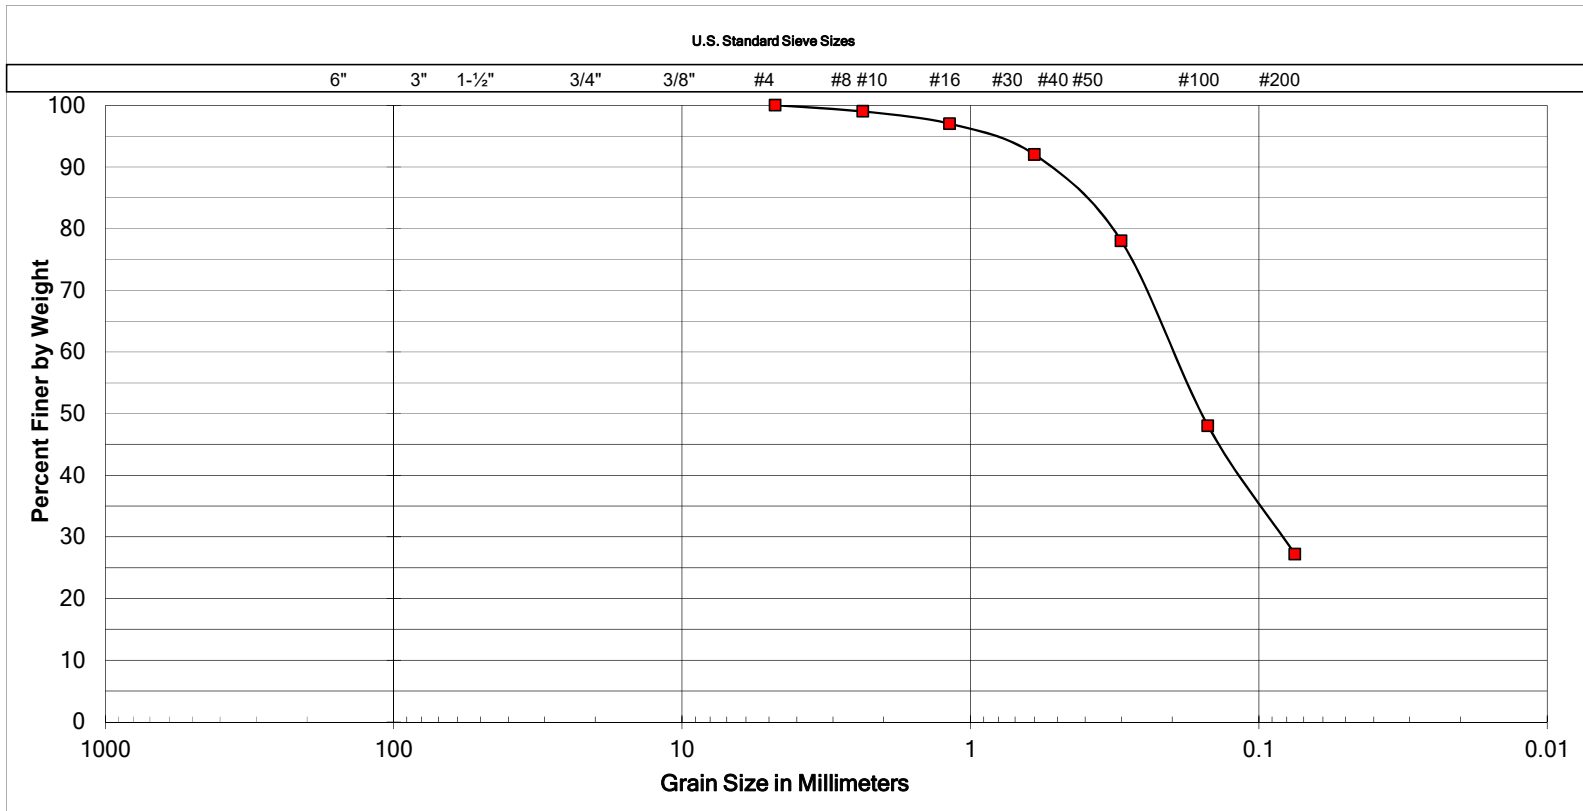
Eastlake High School Chula Vista, California	
By: EMW	Date: October, 2018
Job Number: 180335P4.1-2	Figure: II-9

SAMPLE LOCATION
B-10 at 5½ to 6½ feet

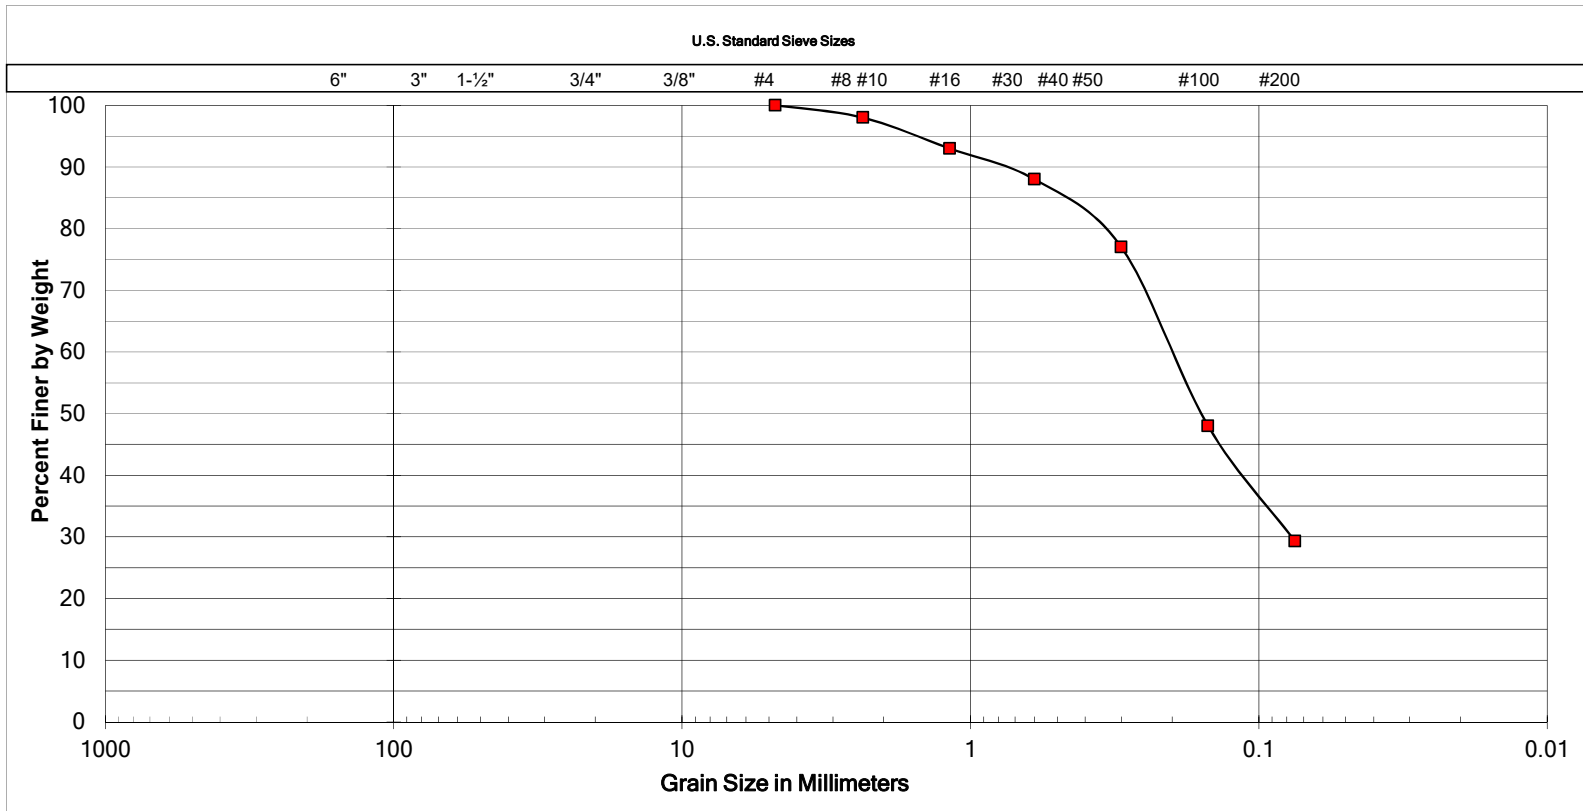
SAMPLE LOCATION
P-1 at ½ to 5 feet

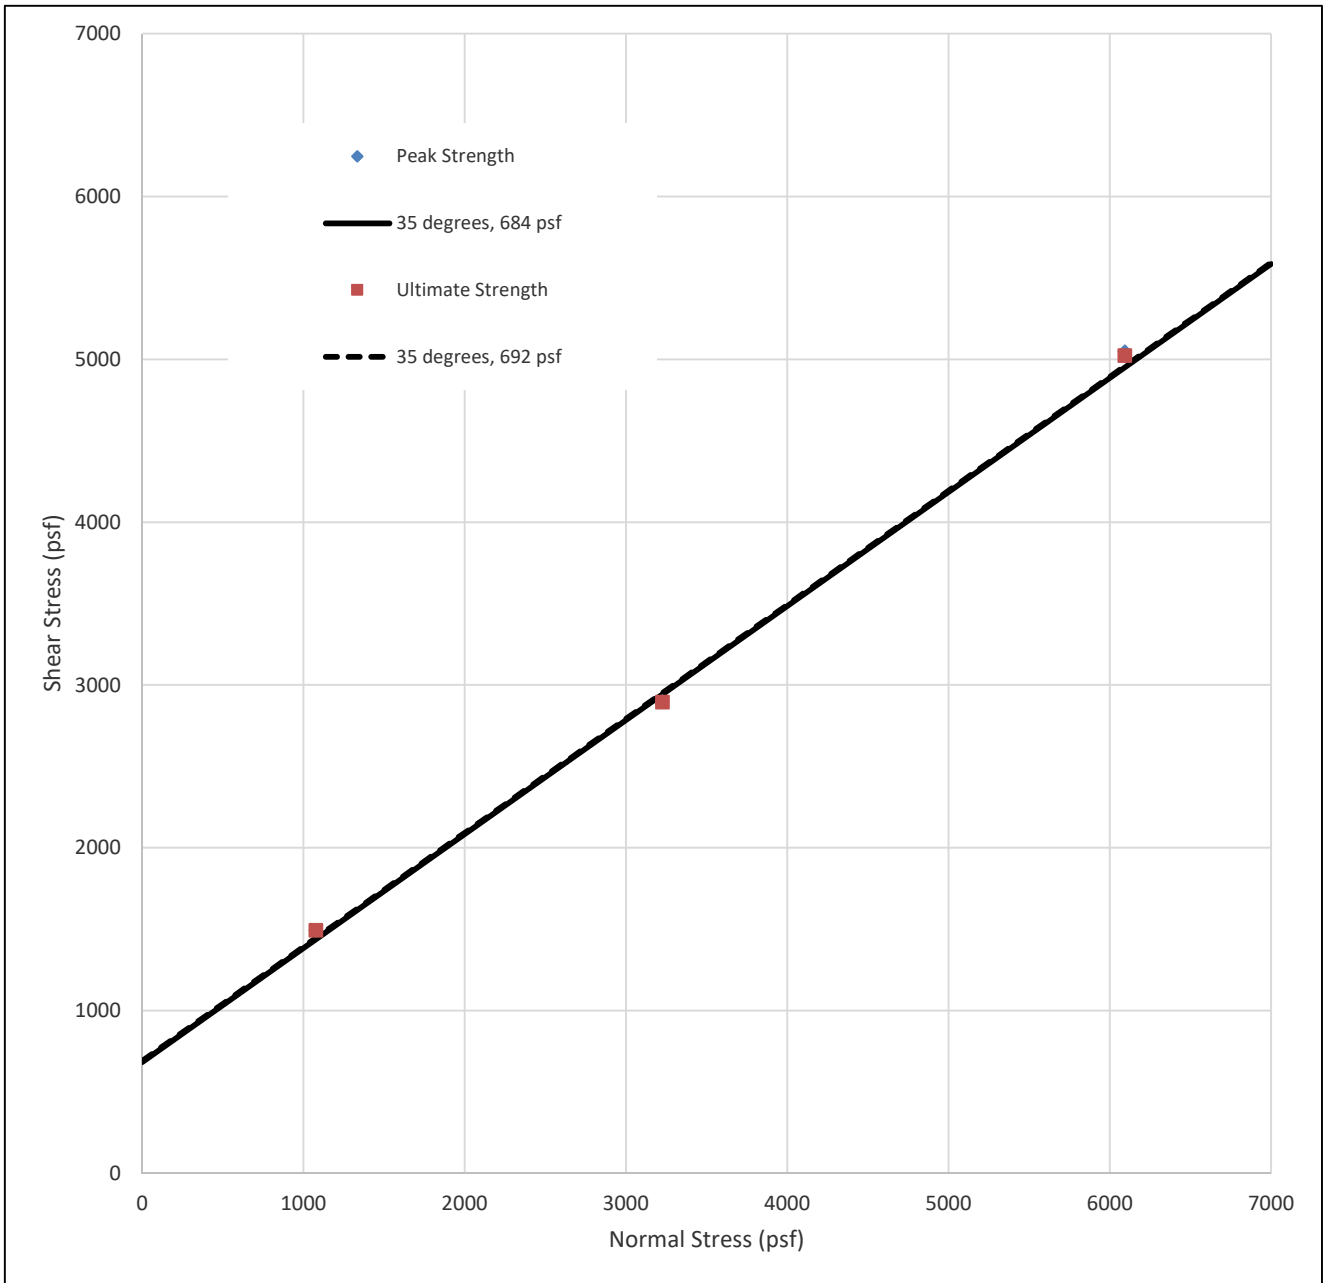
SCST Inc.	Eastlake High School Chula Vista, California	
	By: EMW	Date: October, 2018
	Job Number: 180335P4.1-2	Figure: II-12

SAMPLE ID: B-2 at 6 to 6½ feet	Φ	Peak	Ultimate
		35 °	35 °
CLAYEY SAND	c	684 psf	692 psf
NOTES: Insitu	γ _d	Initial	Final
		103.1 pcf	103.1 pcf
Strain Rate: 0.003 in/min	w _c	11.1 %	19.8 %
Sample was consolidated and drained	Saturation	48 %	85 %

- **DIRECT SHEAR:** Direct shear tests were performed on selected samples in accordance with ASTM D3080. The shear stress was applied at a constant rate of strain of 0.003 inch per minute.

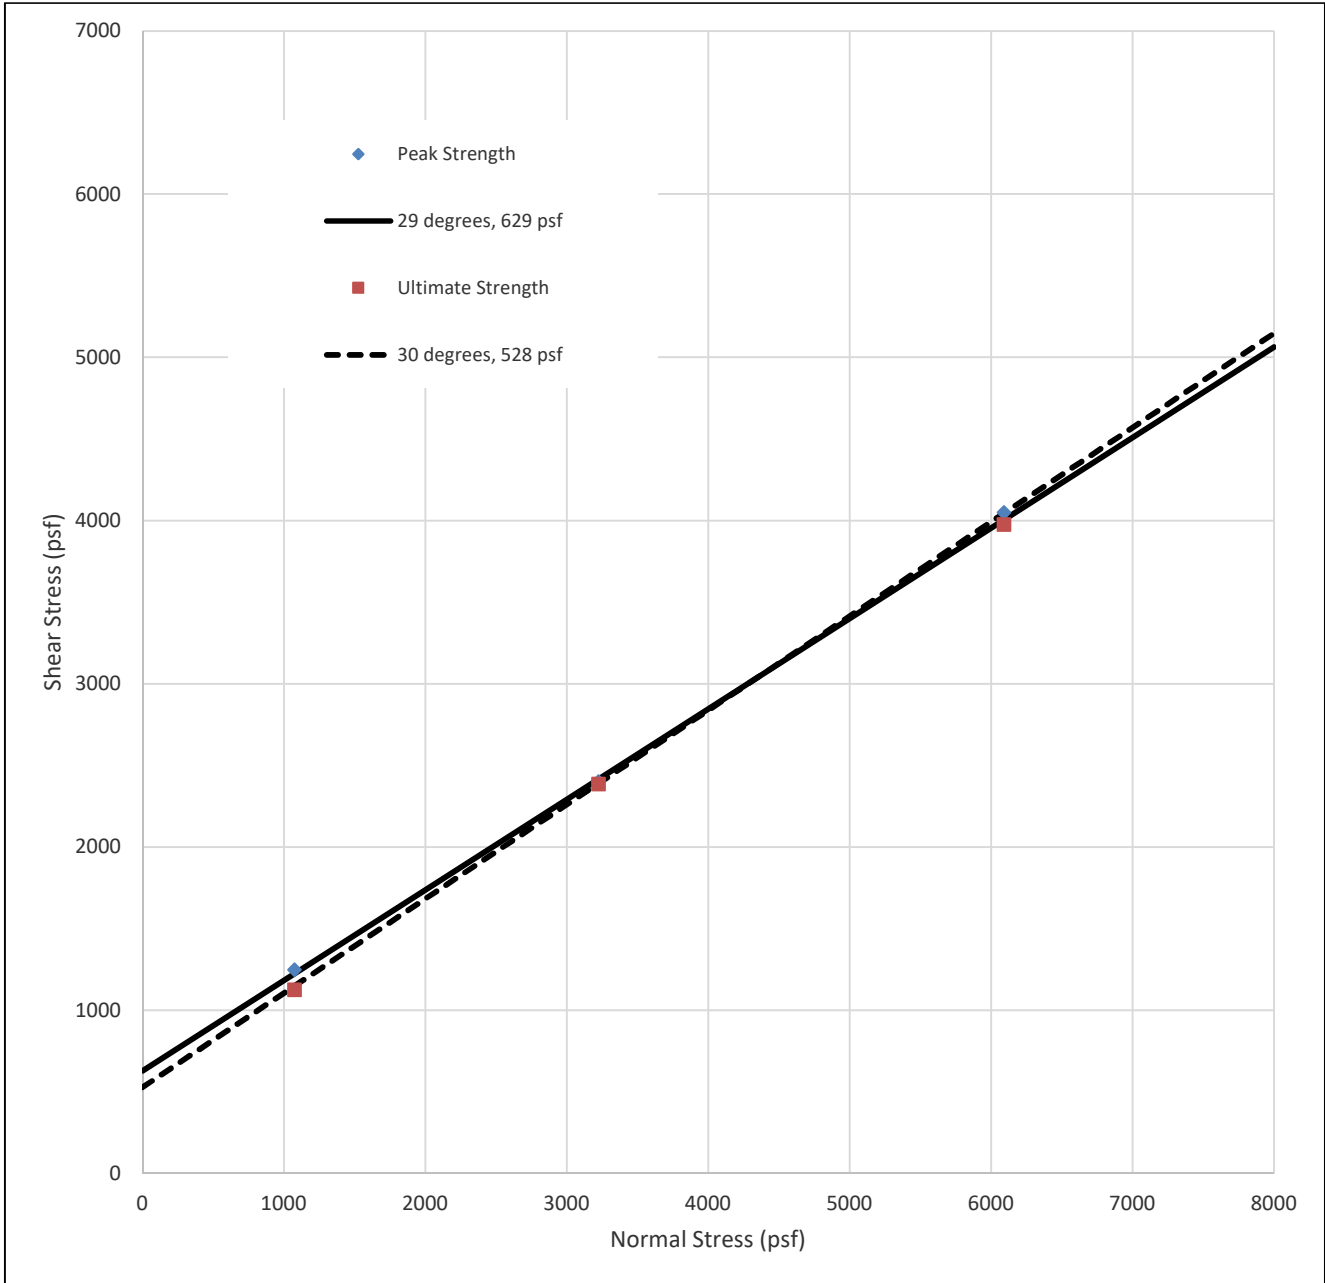
By: EMW	Date: October, 2018
Job Number: 180335P4.1-2	Figure: II-13

SAMPLE ID: B-3 at 3½ to 4 feet	Φ	Peak	Ultimate
		29 °	30 °
SILTY SAND	c	629 psf	528 psf
NOTES: Insitu Strain Rate: 0.003 in/min Sample was consolidated and drained	γ _d w _c Saturation	Initial	Final
		107.6 pcf	109.5 pcf
		16.8 %	20.6 %
		81 %	100 %

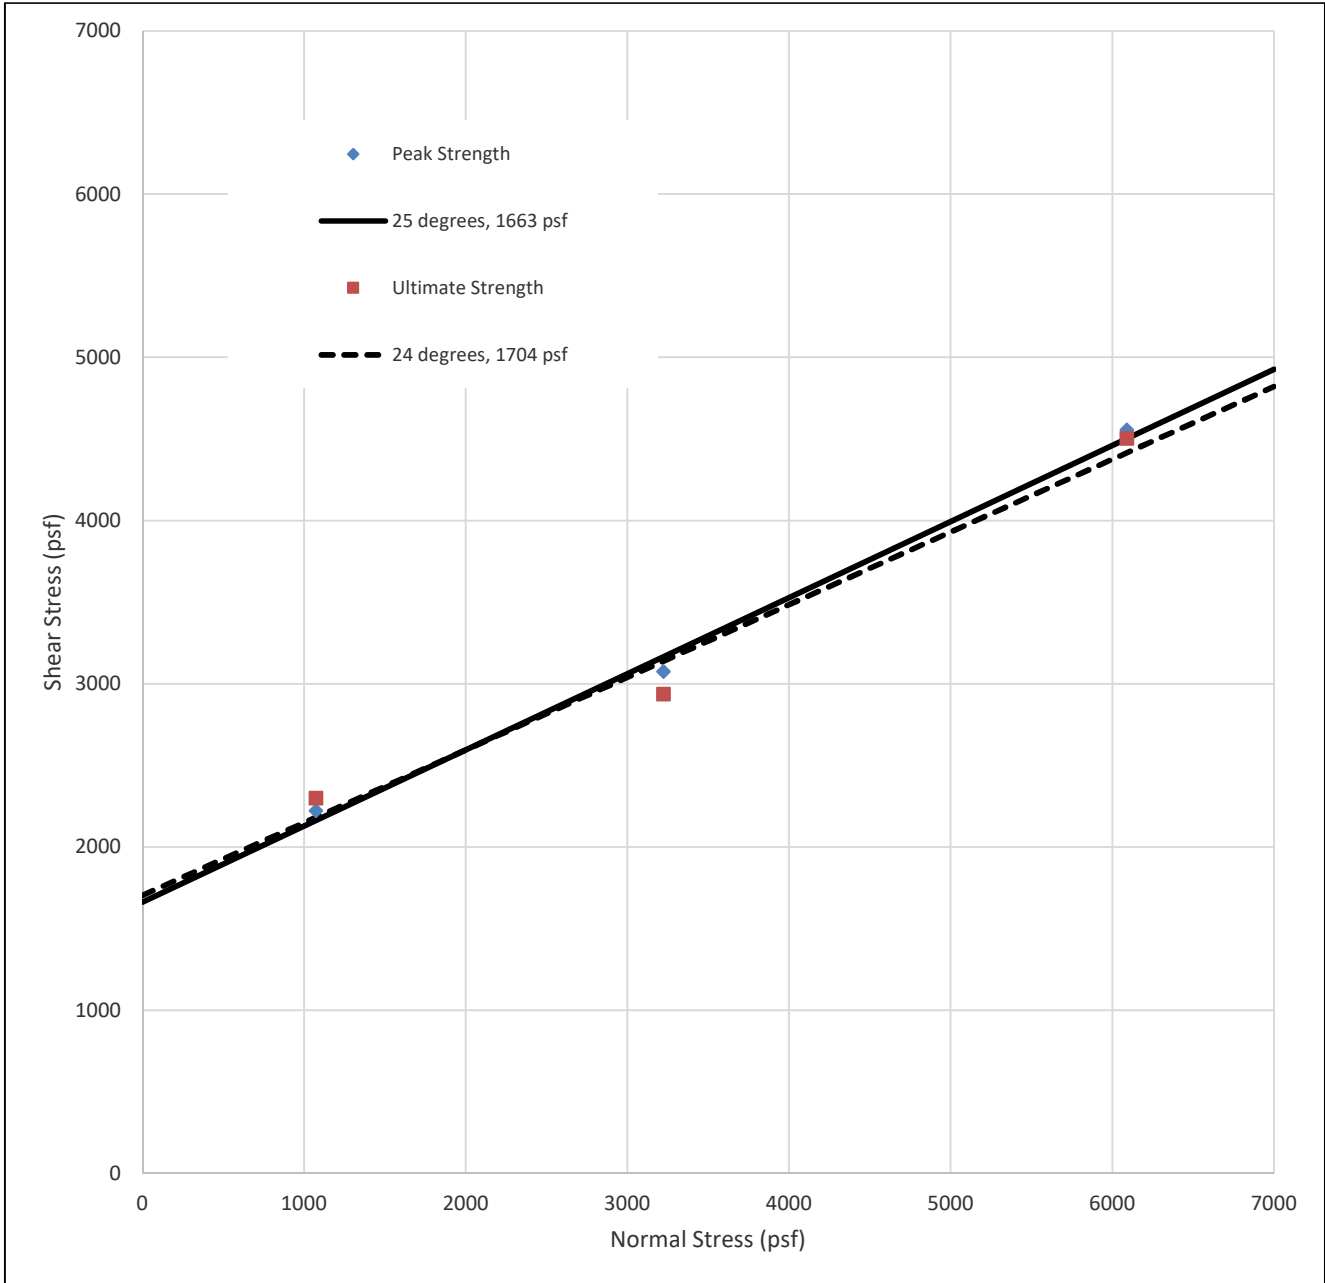
By:	EMW	Date:	October, 2018
Job Number:	180335P4.1-2	Figure:	II-14

SAMPLE ID: B-7 at 3½ to 4 feet

LEAN CLAY
