PRELIMINARY GEOTECHNICAL INVESTIGATION AND INFILTRATION FEASIBILITY STUDY

EASTLAKE HIGH SCHOOL

**Eastlake Parkway
Chula Vista, California**

Prepared By:
SCST, Inc.
6280 Riverdale Street
San Diego, California 92120

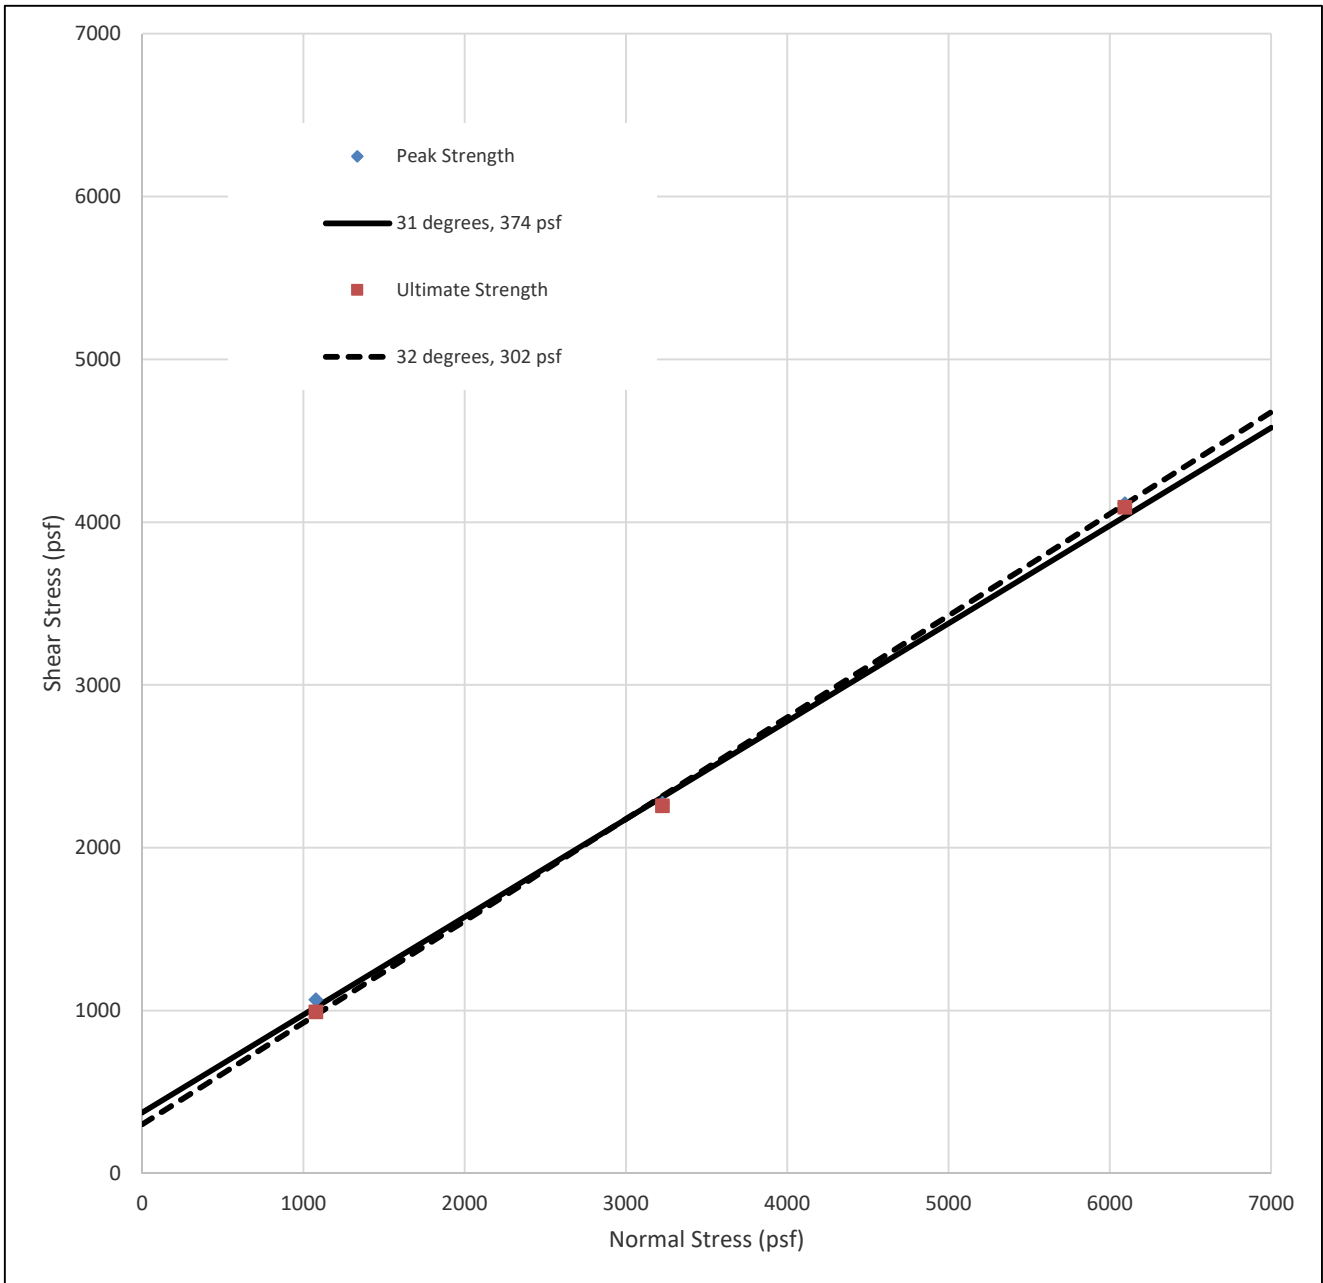
By:	EMW	Date:	October, 2018
Job Number:	180335P4.1-2	Figure:	II-15

SAMPLE ID:	B-9 at 6 to 6½ feet	Φ	Peak 31 °	Ultimate 32 °
SILTY SAND		c	374 psf	302 psf
NOTES: In situ		γ_d	Initial 102.0 pcf	Final 102.0 pcf
Strain Rate: 0.003 in/min		w_c	13.2 %	20.5 %
Sample was consolidated and drained		Saturation	55 %	86 %

- **DIRECT SHEAR:** Direct shear tests were performed on selected samples in accordance with ASTM D3080. The shear stress was applied at a constant rate of strain of 0.003 inch per minute.

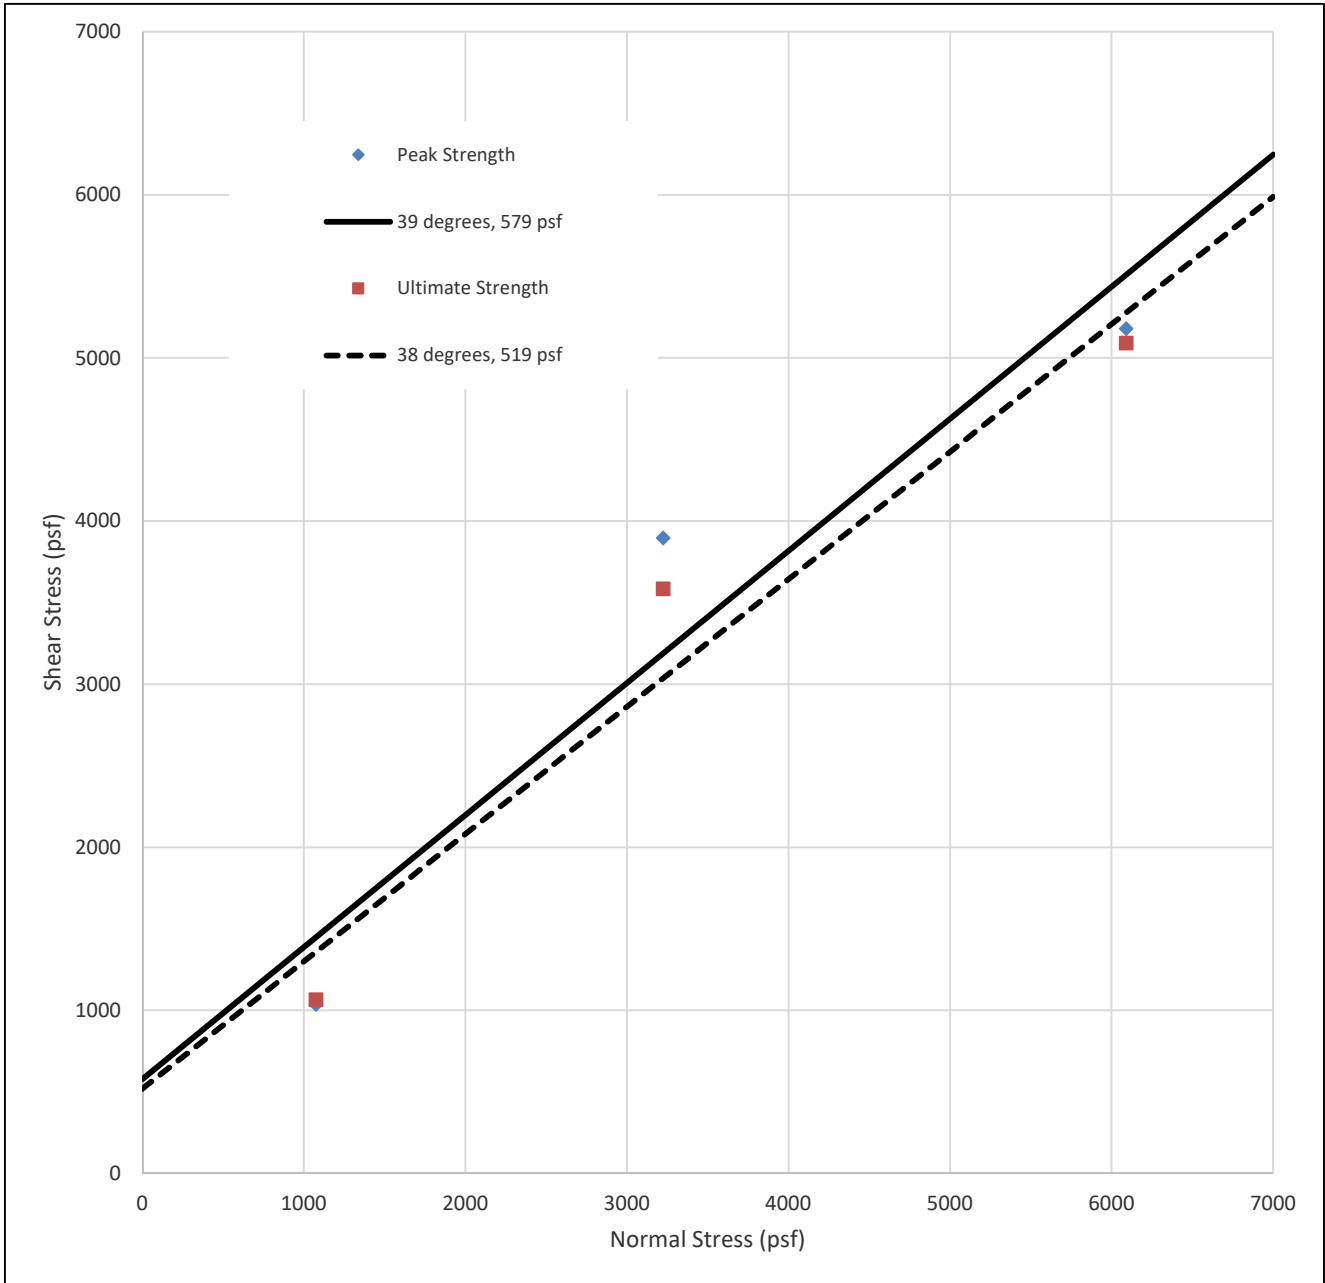
SAMPLE ID: B-10 at 16 to 16½ feet

Clayey Sand
