**LIMITED  
GEOTECHNICAL INVESTIGATION AND  
INFILTRATION FEASIBILITY STUDY**

**CLAY AVENUE MINI PARK  
SAN DIEGO, CALIFORNIA**

**JANUARY 22, 2021  
PROJECT NO. G2645-11-01**

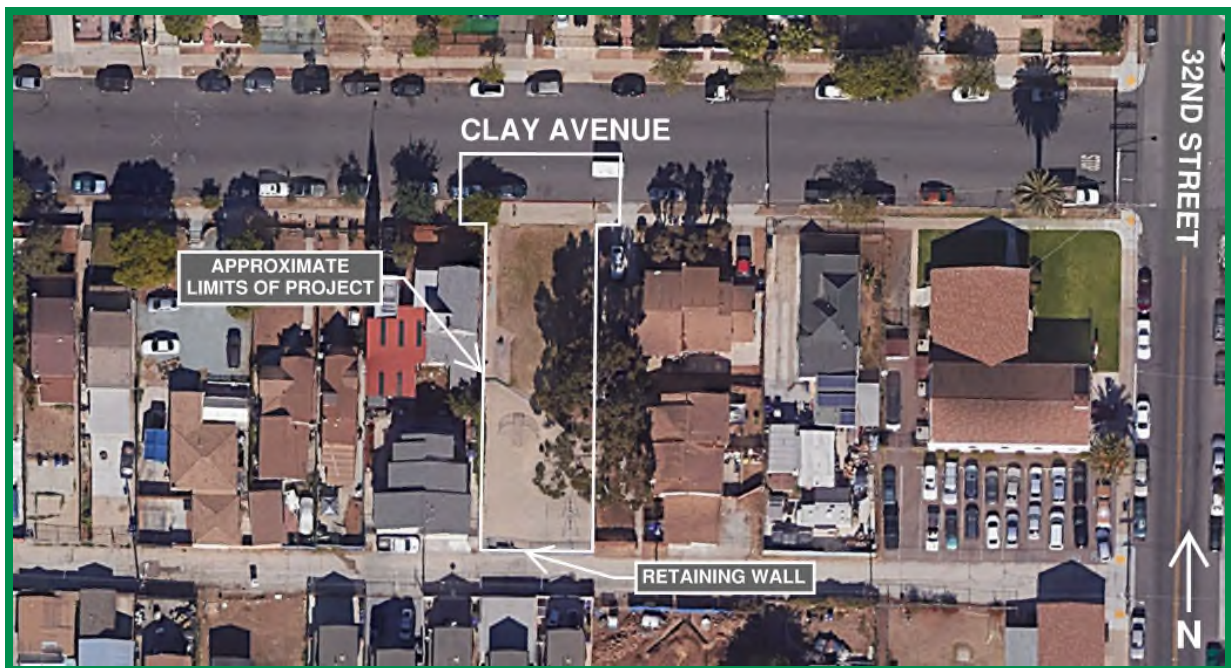
Existing Site Plan

The site is located on the south side of Clay Avenue, west of 32<sup>nd</sup> Street and east of 31<sup>st</sup> Street in San Diego, California. The park currently consists of a grass turf and a sand playground area with a retaining wall along the southern boundary that is approximately 2.5 feet in height as shown in the Existing Site Plan. The site slopes gently to the south with a total relief of 3 feet from elevations of roughly 79 to 82 feet mean sea level MSL.

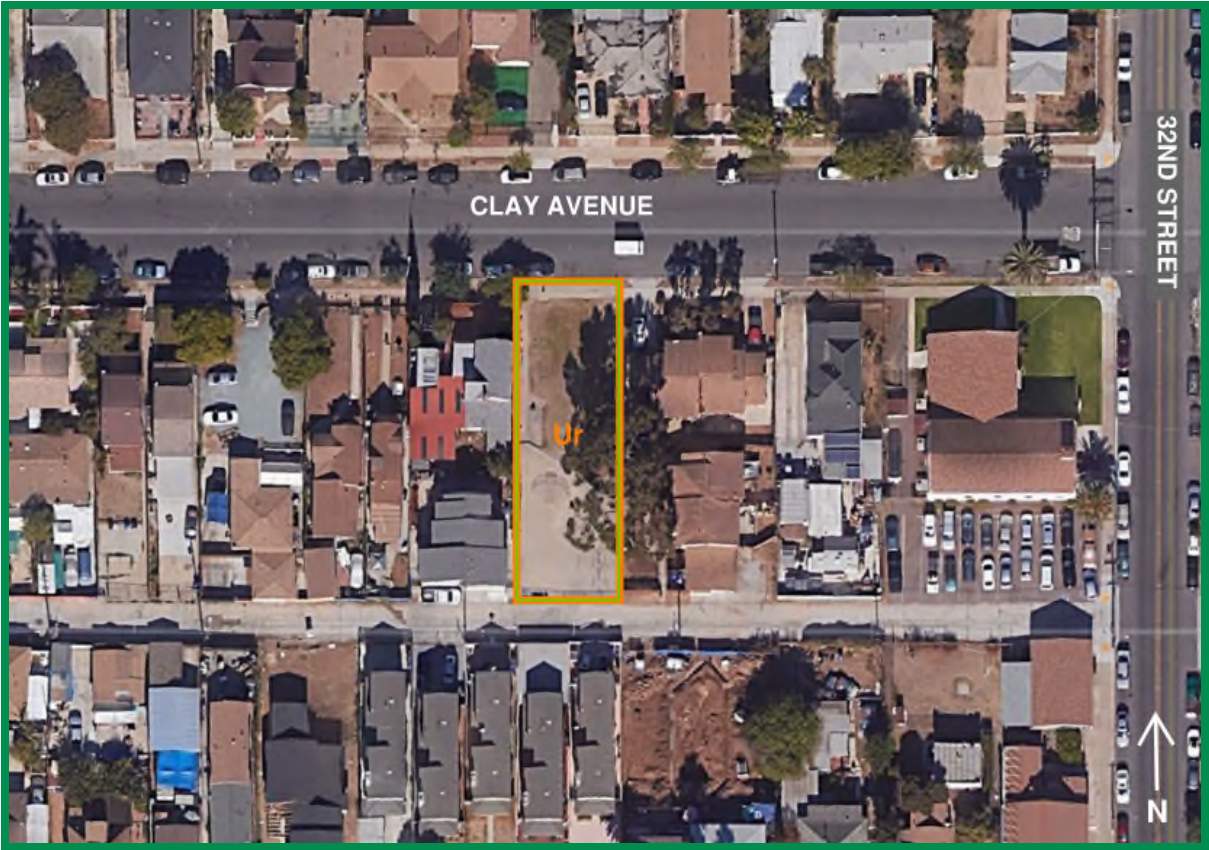
The property is underlain by Old Paralac Deposits and the San Diego Formation and is mapped as “Urban Land.” The Hydrologic Soil Group Map presents output from the USDA website showing the limits of the soil units.
