**GEOTECHNICAL INVESTIGATION
CHILD DEVELOPMENT CENTER
SHADE STRUCTURE PROJECT
GROSSMONT HIGH SCHOOL
1100 MURRAY DRIVE
EL CAJON, CALIFORNIA**

Project Number 12429.034

Issue Date June 28, 2023

**Subject: Geotechnical Investigation
Child Development Center Shade Structure Project
Grossmont High School
1100 Murray Drive
El Cajon, California**

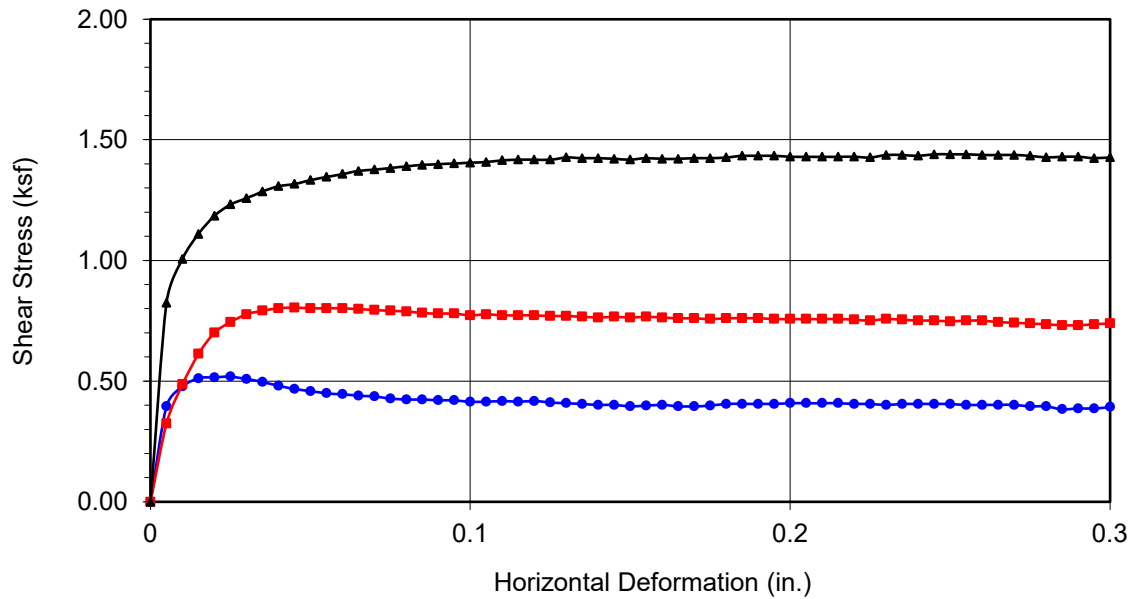
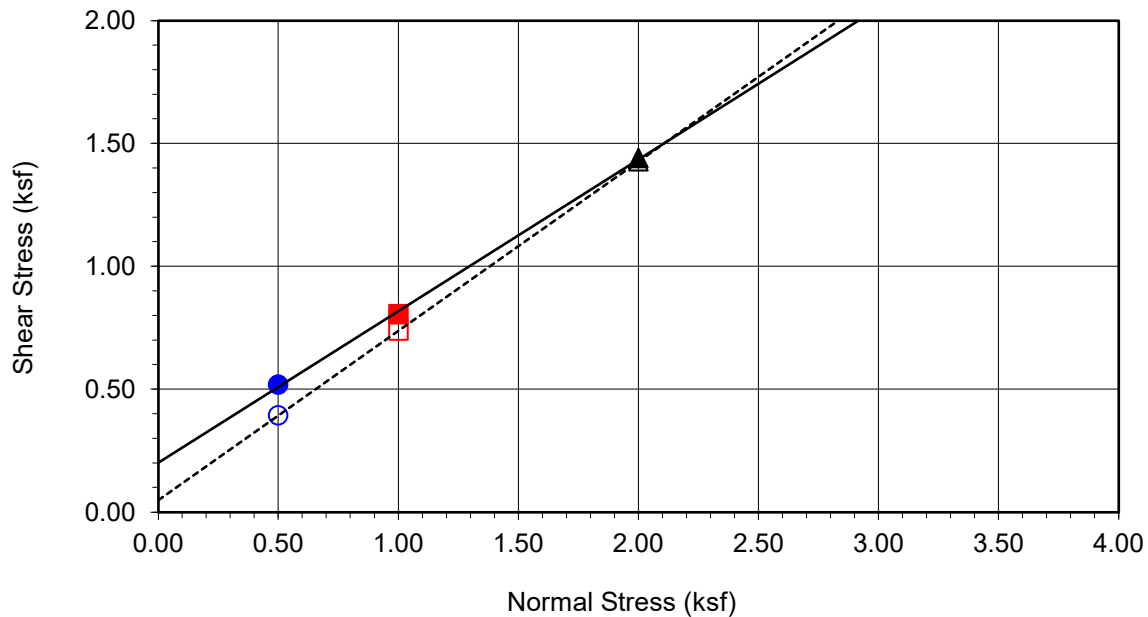
Boring No.	HA-3	
Sample No.	B-1	
Depth (ft)	0.5-2.0	
<u>Sample Type:</u> 90% Remold		
<u>Soil Identification:</u> Dark brown clayey sand with gravel (SC)g		
<u>Strength Parameters</u>		
	C (psf)	ϕ (°)
Peak	202	32
Ultimate	49	35

Normal Stress (kip/ft ²)	0.500	1.000	2.000
Peak Shear Stress (kip/ft ²)	● 0.519	■ 0.805	▲ 1.440
Shear Stress @ End of Test (ksf)	○ 0.393	□ 0.739	△ 1.427
Deformation Rate (in./min.)	0.0025	0.0025	0.0025
Initial Sample Height (in.)	1.000	1.000	1.000
Diameter (in.)	2.415	2.415	2.415
Initial Moisture Content (%)	8.80	8.80	8.80
Dry Density (pcf)	116.1	116.1	116.2
Saturation (%)	52.5	52.5	52.7
Soil Height Before Shearing (in.)	1.0037	0.9925	0.9872
Final Moisture Content (%)	16.4	15.9	14.9

Direct Shear Test: A direct shear test was performed on a selected remolded sample which was soaked for a minimum of 24 hours under a surcharge equal to the applied normal force during testing. After transfer of the sample to the shear box and reloading of the sample, the pore pressures set up in the sample (due to the transfer) were allowed to dissipate for a period of approximately 1 hour prior to application of shearing force. The sample was tested under various normal loads utilizing a motor-driven, strain-controlled, direct-shear testing apparatus at a strain rate of less 0.05 inches per minute. The test result is presented on the attached figure.

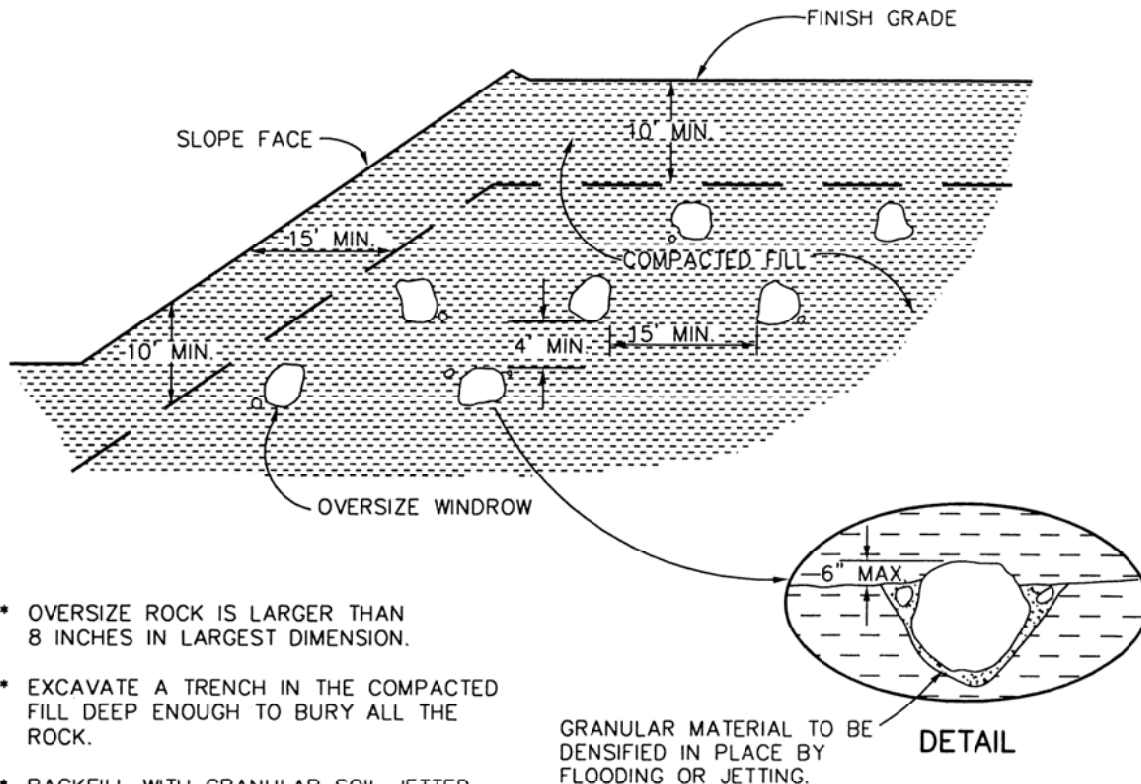
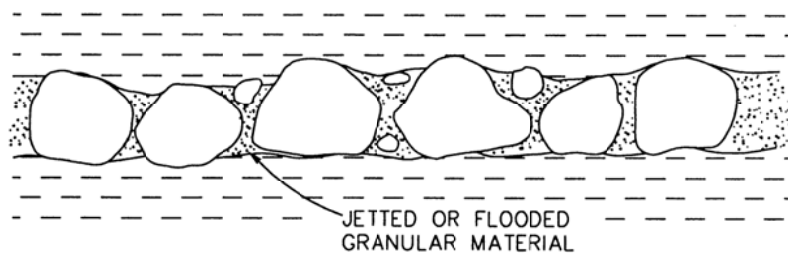
OVERSIZE ROCK DISPOSAL

- * OVERSIZE ROCK IS LARGER THAN 8 INCHES IN LARGEST DIMENSION.
- * EXCAVATE A TRENCH IN THE COMPACTED FILL DEEP ENOUGH TO BURY ALL THE ROCK.
- * BACKFILL WITH GRANULAR SOIL JETTED OR FLOODED IN PLACE TO FILL ALL THE VOIDS.
- * DO NOT BURY ROCK WITHIN 10 FEET OF FINISH GRADE.
- * WINDROW OF BURIED ROCK SHALL BE PARALLEL TO THE FINISHED SLOPE.

GRANULAR MATERIAL TO BE DENSIFIED IN PLACE BY FLOODING OR JETTING.

TYPICAL PROFILE ALONG WINDROW

GENERAL EARTHWORK AND
GRADING SPECIFICATIONS
STANDARD DETAIL B

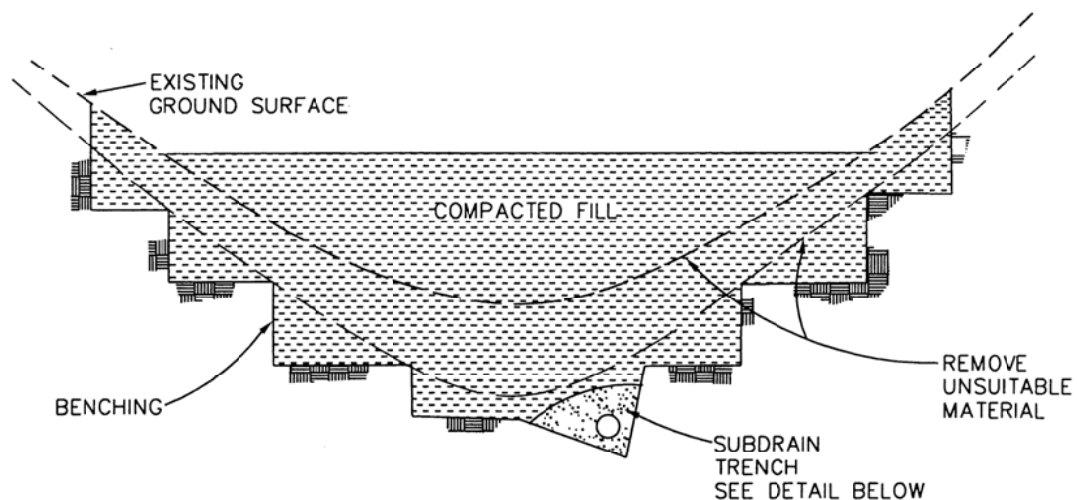
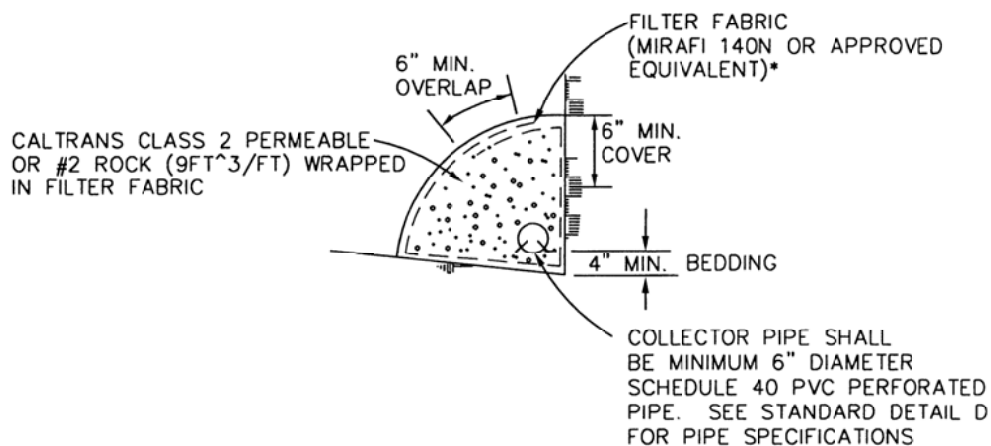
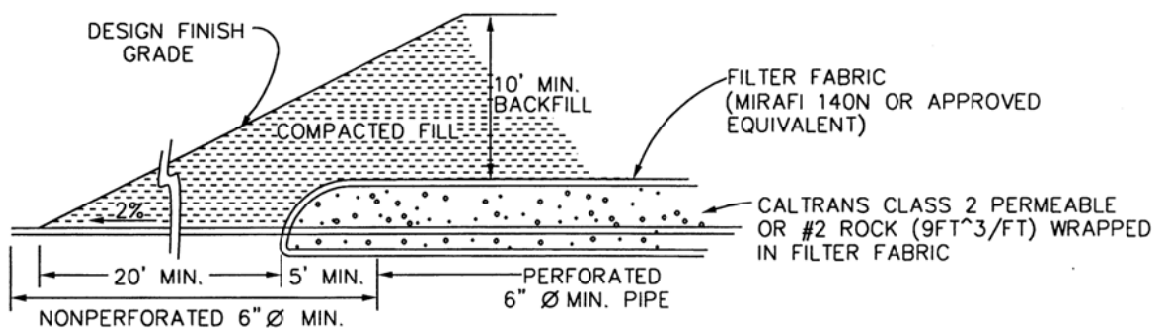
SUBDRAIN DETAIL

DETAIL OF CANYON SUBDRAIN OUTLET

CANYON SUBDRAINS

GENERAL EARTHWORK AND
GRADING SPECIFICATIONS
STANDARD DETAIL C

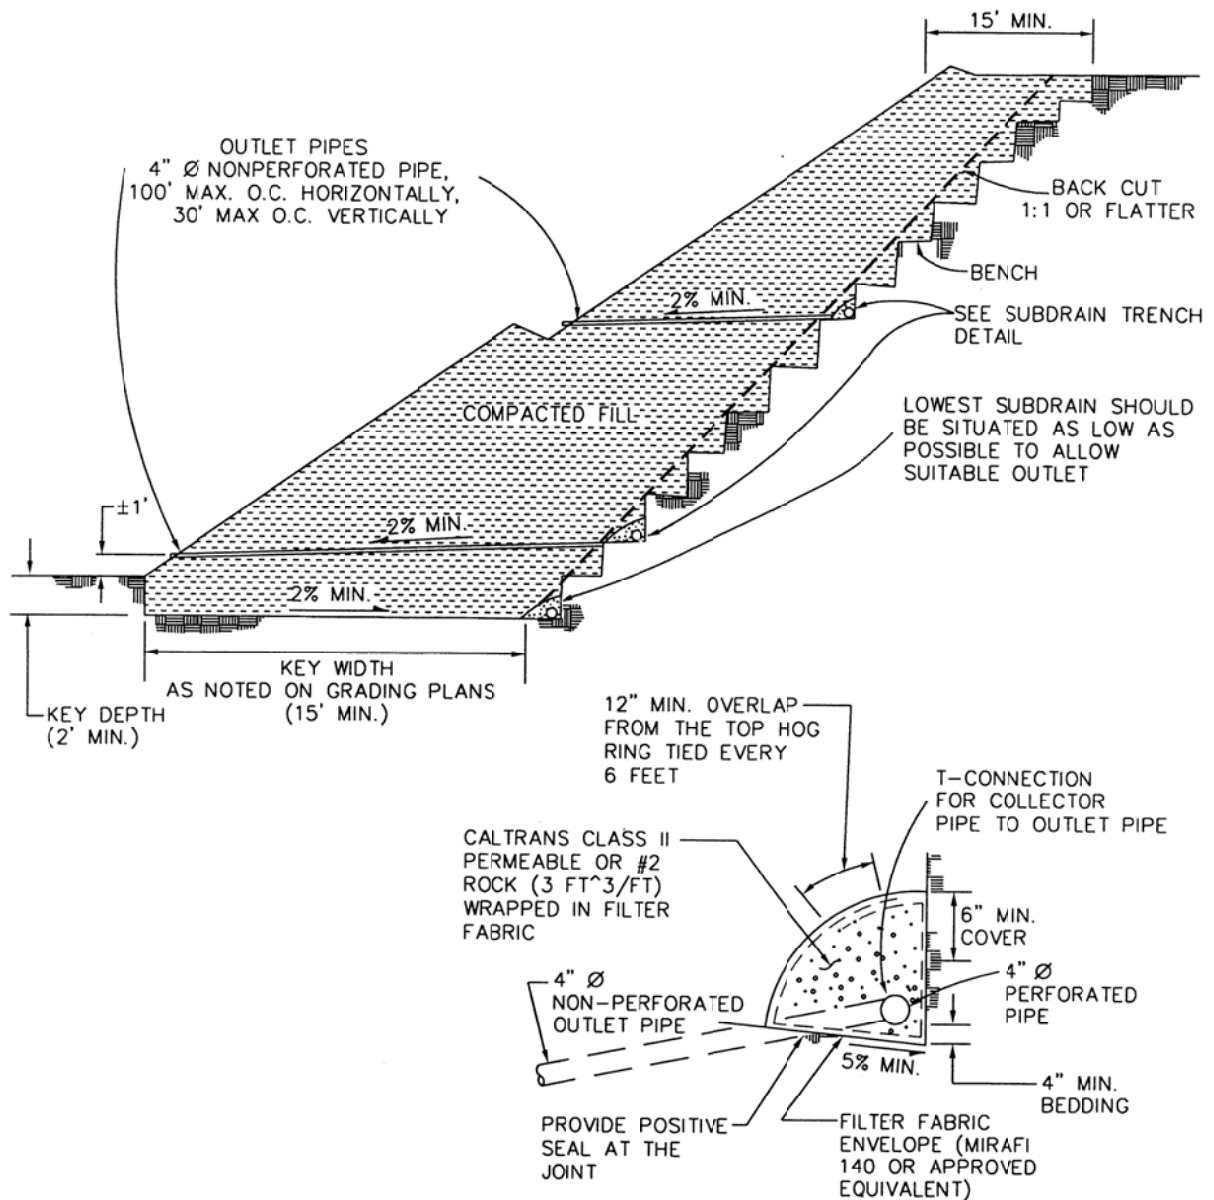
SUBDRAIN TRENCH DETAIL

SUBDRAIN INSTALLATION – subdrain collector pipe shall be installed with perforation down or, unless otherwise designated by the geotechnical consultant. Outlet pipes shall be non-perforated pipe. The subdrain pipe shall have at least 8 perforations uniformly spaced per foot. Perforation shall be 1/4" to 1/2" if drill holes are used. All subdrain pipes shall have a gradient of at least 2% towards the outlet.

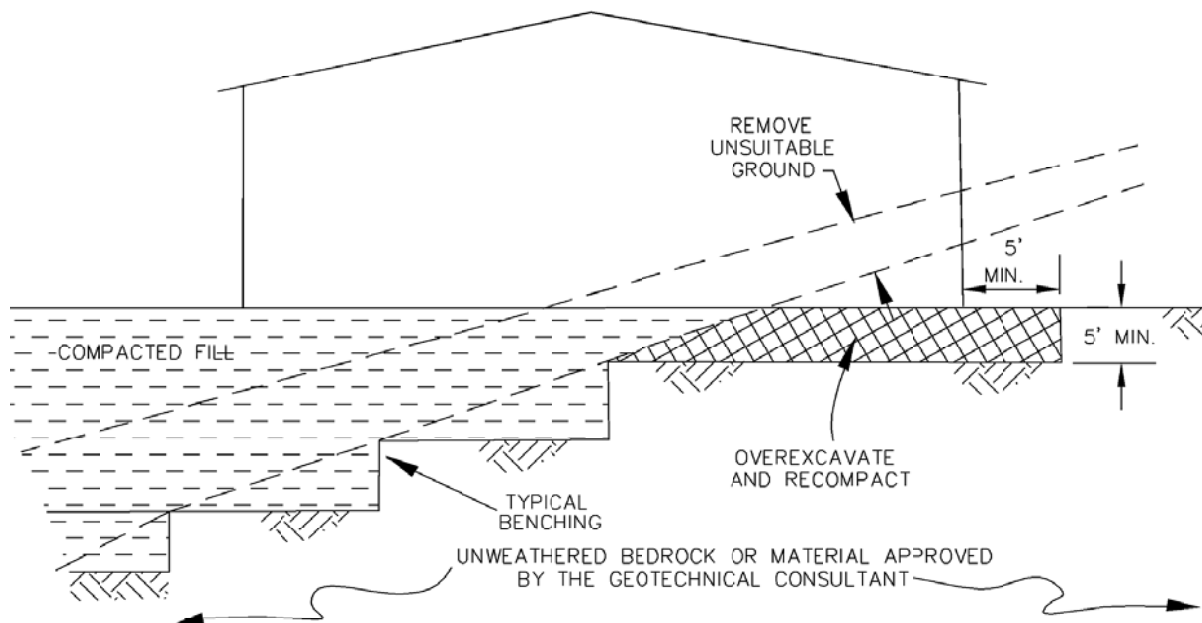
CUT-FILL TRANSITION LOT OVEREXCAVATION

TRANSITION LOT FILLS

GENERAL EARTHWORK AND
GRADING SPECIFICATIONS
STANDARD DETAIL E

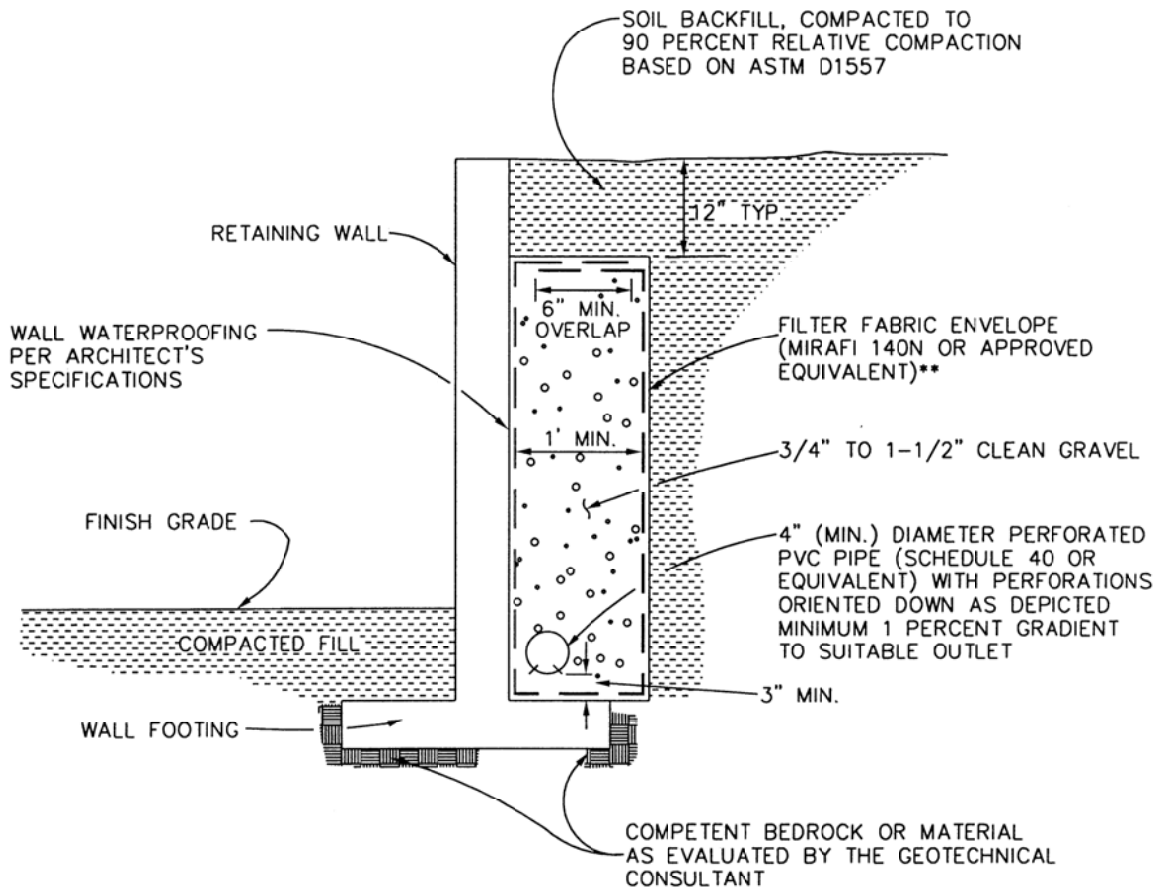
RETAINING WALL DRAINAGE

NOTE: UPON REVIEW BY THE GEOTECHNICAL CONSULTANT, COMPOSITE DRAINAGE PRODUCTS SUCH AS MIRADRAIN OR J-DRAIN MAY BE USED AS AN ALTERNATIVE TO GRAVEL OR CLASS 2 PERMEABLE MATERIAL. INSTALLATION SHOULD BE PERFORMED IN ACCORDANCE WITH MANUFACTURER'S SPECIFICATIONS.

GENERAL EARTHWORK AND
GRADING SPECIFICATIONS
STANDARD DETAIL F
